The Lodge, Doddershall

HISTORIC BUILDING REPORT / December 2013

including HS2 high-speed rail line impact assessment

Report number
BAS/2013-04

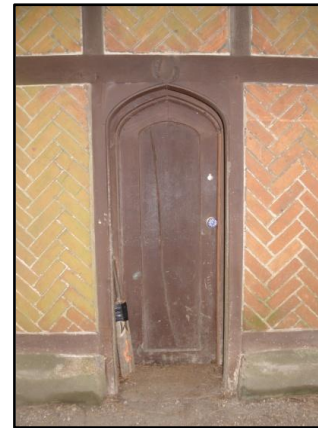
Figure 4: Doorway with four-centred arch.

The same can probably be said for the six matching doorways with single-panelled polished doors topped by four-centred arches. This form of arch was in use from the 15th to 17th centuries.¹¹

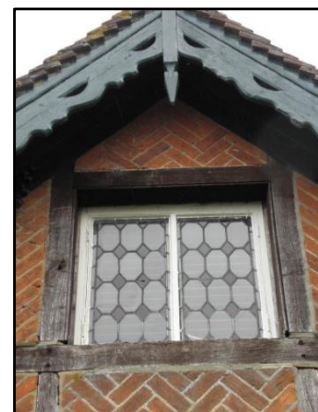
Figure 5: Octagonal leaded lights above the driveway.

The fact that the leaded-light windows in metal frames are in three different styles – rectangular, diamond, and octagonal with coloured diamond insets – suggest that they too were not made for this building but have been recycled from elsewhere.

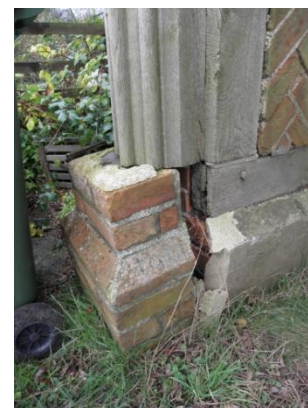
The west side of the archway over the drive matches that on the east in all respects. The brick base at the foot of the moulded wooden pillar at the north-west corner of the archway has broken away (see figure 6) revealing a straight joint between this and the building plinth.

Figure 6: The brick base of one of the archway pillars.

The four moulded wooden pillars that stand at the corners of the driveway arch are also decorative and have no structural function. The brick base of the north-western pillar has broken away, revealing a straight brickwork joint with the building's main plinth, showing that the pillars were added after the main structure had been built.

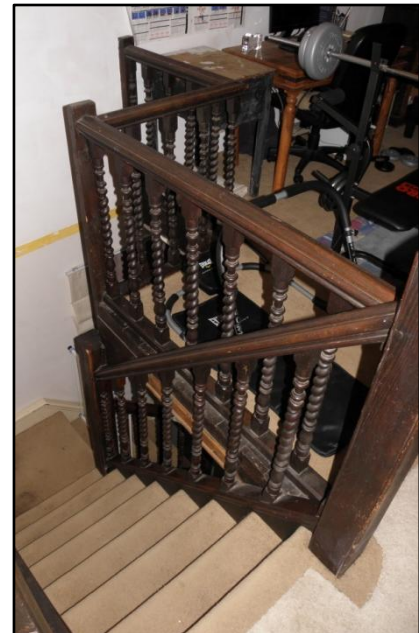
Figure 9: The staircase.

square 4-inch newel posts have plain moulded corners. Two newel posts rise from floor to ceiling of the ground floor. A moulded wooden banister is supported on multiple turned spindles and this continues around the stair well on the first floor. In several places these relatively high-quality materials have been fixed together rather crudely, using screws and odd pieces of wood.

The staircase, though not high-status, has complex turned balusters, a moulded banister rail and newel posts with moulded corners – but in several places these have been crudely fixed together. The staircase has been brought from elsewhere and made to fit. The style of the balusters

and the aging of the wood, perhaps oak, also suggest that the original staircase is more likely to date from the 17th or 18th centuries than the 1890s.¹²

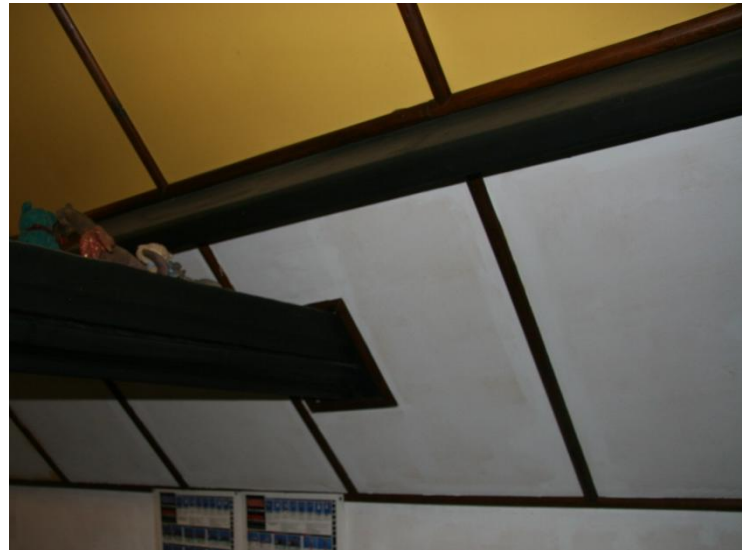
Figure 10: The curious position of the cross-beam in the study: below and separate from the roof purlins.

This heavy beam, however, is not jointed to the roof-purlins, as would be expected. Instead it meets the roof slope six inches below them. In this position it is more likely to be decorative than structural.

Another example can be seen in the heavily moulded, black-stained beams on the upper floor which share the same moulded profiles as the pillars. The disjunction between these beams and the purlins of the roof structure indicates that these too are more decorative than structural. They may have been inserted after the roof had been built.

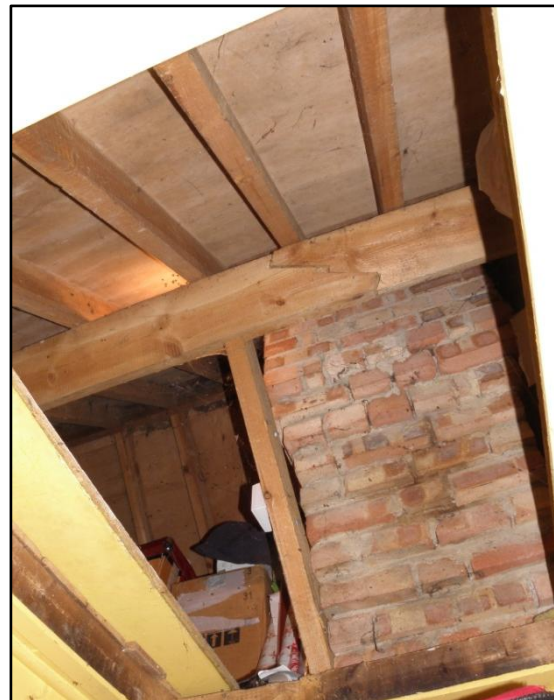
In the ceiling of the lobby is a hatch giving access to the roof space above the south wing. This was the only point in the survey where the roof timbers were visible. They were of clean, plain softwood, clearly of 20th-century date.

Figure 12: Clean modern timbers in the roof space above the south wing.

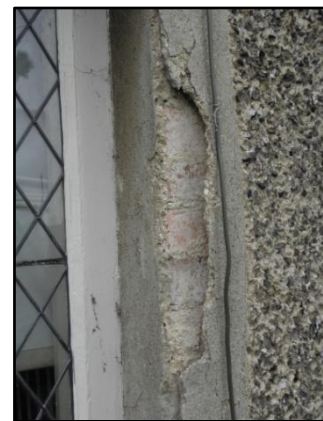
Beyond that the structure of this central bay is well hidden. A small area of failing render on the west elevation has revealed brickwork and lime mortar, but everywhere else the actual building materials are hidden by concrete render externally and plaster and modern wood panelling internally. There are no minor tell-tale cracks to indicate a wooden frame hidden beneath the plaster.

Figure 15: Exposed brickwork in the central bay.

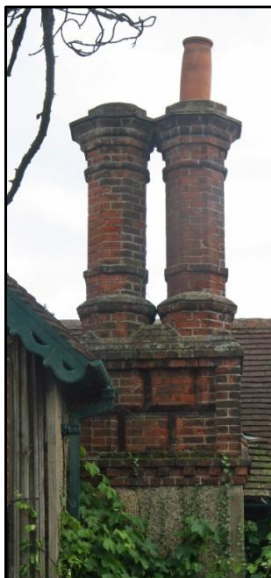
Figure 16: Chimneys on the Lodge...

The three tall octagonal chimney stacks on either side of the archway are out of scale with such a modest building. Although they served fireplaces inside the Lodge, their main intended function was clearly decorative: to mirror the 16th-century chimney stacks on Doddershall House itself. Their style matches exactly.
