# Portway Farm, Twyford

**HISTORIC BUILDING REPORT / April 2011**

Including HS2 high-speed rail line Impact Assessment

Report number  
BAS/2011-03

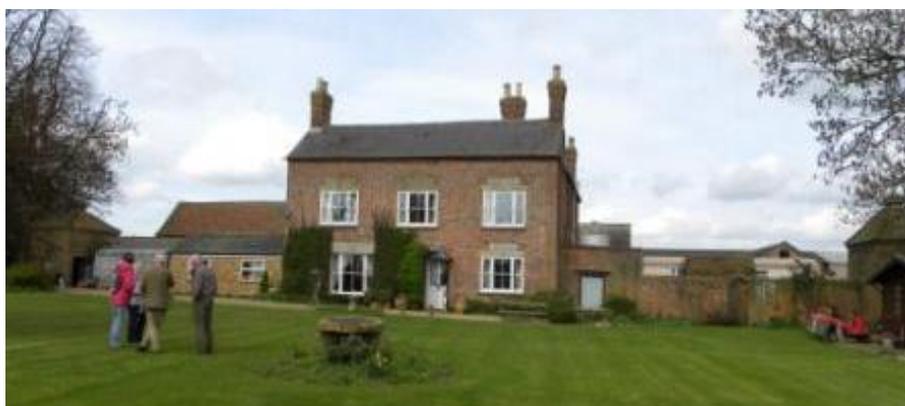
**Figure 1:**  
The front  
elevation of  
Portway  
farmhouse

The farmhouse probably dates from around 1800 but incorporates the kitchen hall of a mid 17<sup>th</sup> century building. To this belong the substantial timber-framed partition between the entrance passage and the kitchen hall, and the open fireplace with its gently cambered,

chamfered bressumer, keyed for plaster and largely blocked up when made into the fireplace for the new kitchen. It has been quite well unblocked and opened out as a feature.

The presence of older fabric is betrayed outside by the front door not being in the middle of the new front, suggesting that the house may have been rebuilt on the old foundations. The 17<sup>th</sup> century farmhouse was probably one room deep like the present front block. The top storey was probably added at the time of the rebuilding.

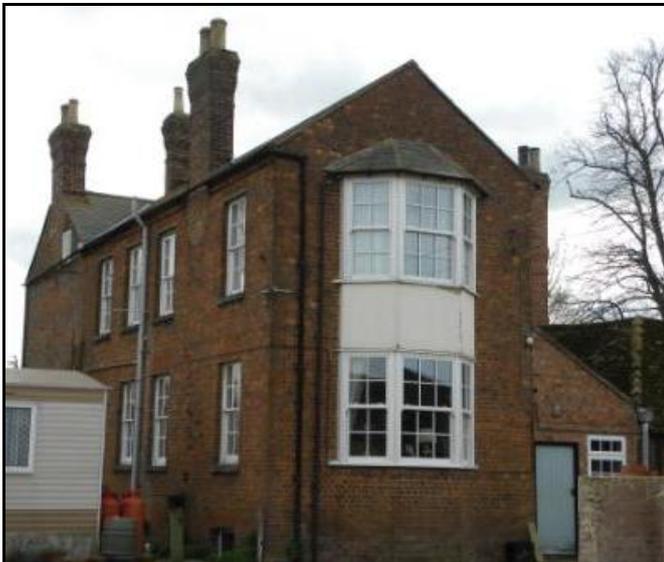
The red brick wing to the rear - built, surprisingly, in English bond - was probably added around 1830, with a dairy in a semi-basement. One of the original horizontal sliding sash windows which lit the dairy on the inner side survives, now internal, showing that the passage on that side was a later addition, possibly mid to late 19<sup>th</sup> century.

The stair looks early Victorian, 1830 -1850. The stair of the rebuilt house of c.1800 was probably in a similar position, in a stair projection, before the building of the rear passage hall. The house has an early 19<sup>th</sup> century ironwork porch.

Figure 2: The rear elevation of Portway farmhouse.

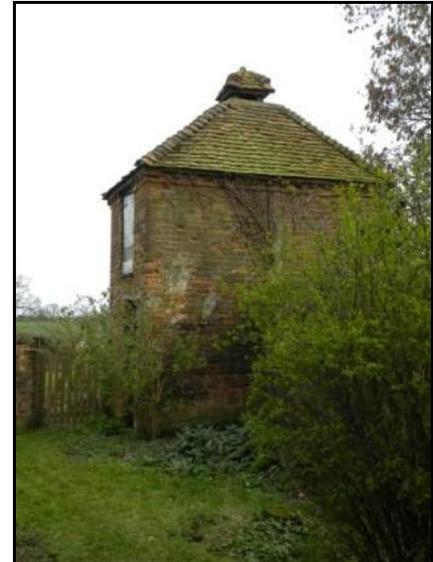
Figure 3: One of the flanking dovecotes

The rebuilt farmhouse would look rather gaunt and charmless, with its big tripartite ground and first floor windows, now glazed in late 19<sup>th</sup> century style with plate glass sashes, were it not for the dovecotes, joined to the house by walls hiding the big farmyard behind, and forming a symmetrical composition with the house.

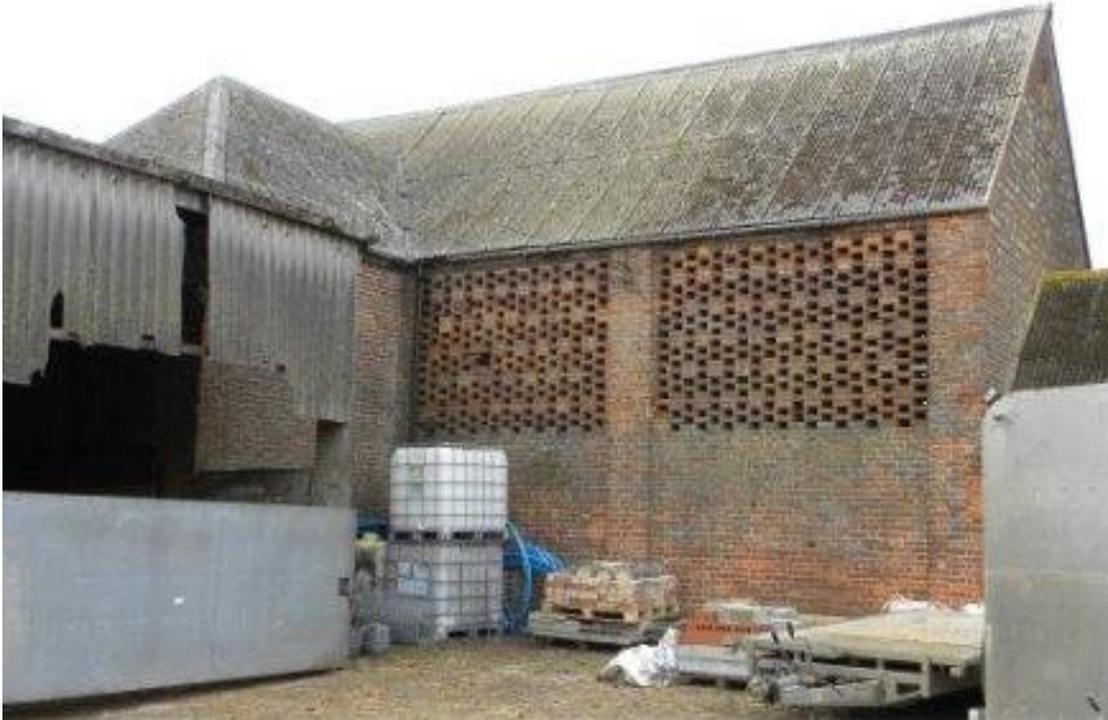
The large, brick-built threshing barn behind the farmhouse is a remarkable farm building, probably dating from the time of the rebuilding of the house. Its mixture of English bond inside and Flemish bond outside, and the big panels of openwork brick to the upper portion is extraordinary. It is a four-bay barn, so that the big full-height front porch is not central, but to left of centre.

It has a granary loft in its hipped roof upper storey above the tall cart entrance.

The rear cart entrance has no porch. It is in line with the porch giving the trough draught for threshing. The barn is now attached to single storey range to the right which is probably mid

19<sup>th</sup> century, and the further single story range at a right angle to it is probably late 19<sup>th</sup> century, with interesting octagonal roof lights.

Figure 4: Portway Farm's unusual threshing barn

This is an intriguing farm complex which would repay further study. The big brick threshing barn with the porch should be considered for listing, which should include the other outbuildings, for group value.

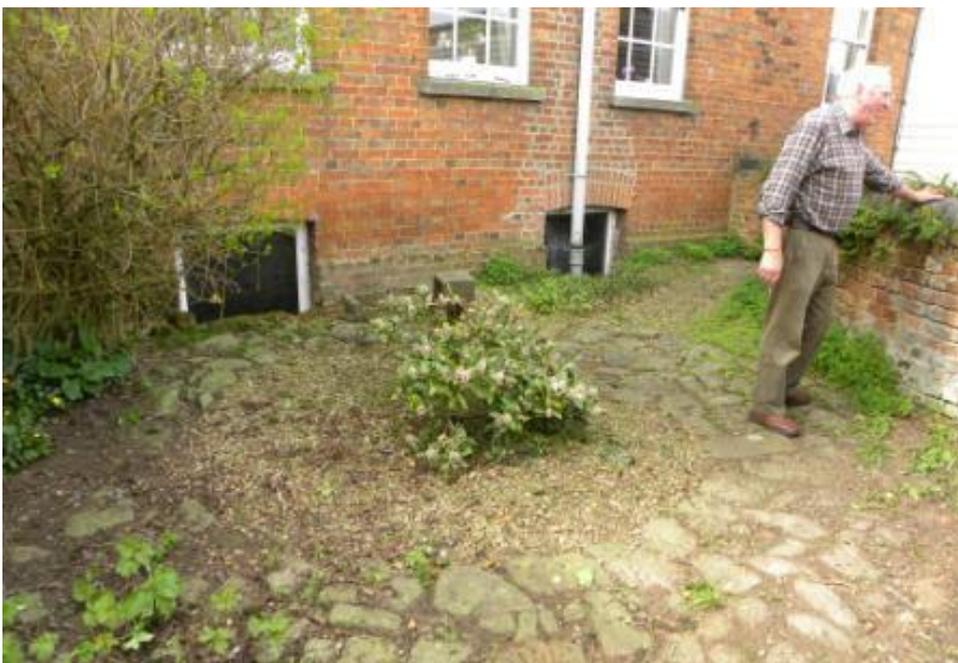
The other lesser barns are probably early to mid 19<sup>th</sup> century with re-used timber trusses. To one side of the rear right wing of the farmhouse is a circle of flagstones with the remains of a vertical spindle in the centre. This was an open air horse or donkey gin, used to power machinery in the dairy, which was probably sited in the basement. This is likely to date from the mid 19<sup>th</sup> century.

Figure 5: Cobbles indicate the location of a horse gin at Portway Farm
