# EXCAVATIONS AT THE MOTTE, WESTON TURVILLE MANOR, 1985

PETER A. ST J. YEOMAN

*Limited rescue excavation bisected part of the Motte ditch. An E-W profile of the ditch was obtained. This was 8 m wide × 2 m deep, with stepped sides and a dished base. The primary filling contained waterlogged organic material and two dressed voussoirs of twelfth-century date. The castle mound is in a good state of preservation, standing to a height of 4 m with a circular summit, 23 m in diameter. The ceramic evidence from the ditch coupled with the nature of the ditch infilling would seem to uphold the documented slighting of the defences in 1173-74 by command of Henry II. Further dumps were deposited during the later manorial development of the site in the thirteenth and fourteenth centuries.*

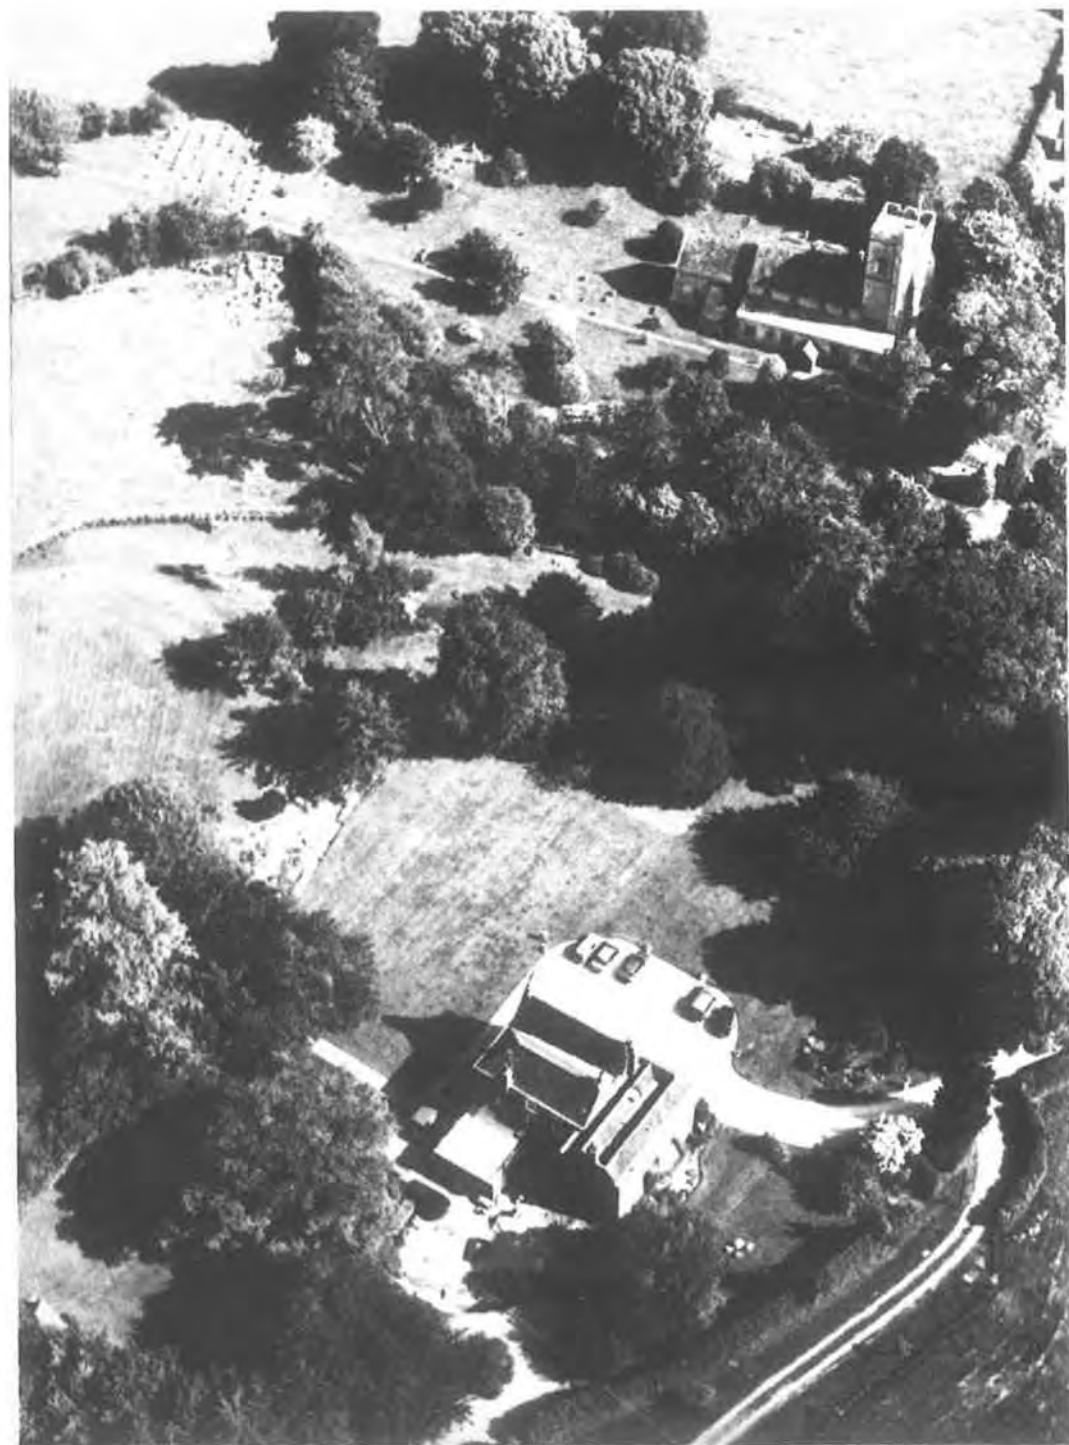
Plate XV. Motte (bottom left, among trees), manor house, church and moats (left of photograph): aerial view, looking S. The excavation can be seen between the house and the bottom of the photograph.

One of the finest motte and bailey castle earthworks in the county is situated a few metres from the Manor House at Weston Turville (SP 859104) and 150 m from the parish church of St Mary's (Pl. XV). The site is 6 km SE of Aylesbury on the E side of the Vale, close to the edge of the Chilterns (Fig. 1). Although sited on Gault Clays the motte lies at the edge of a gravel spread, on which the main area of the village is sited. It stands in the flood plain of a large stream which separates it from the large modern village of Weston Turville to the NW.

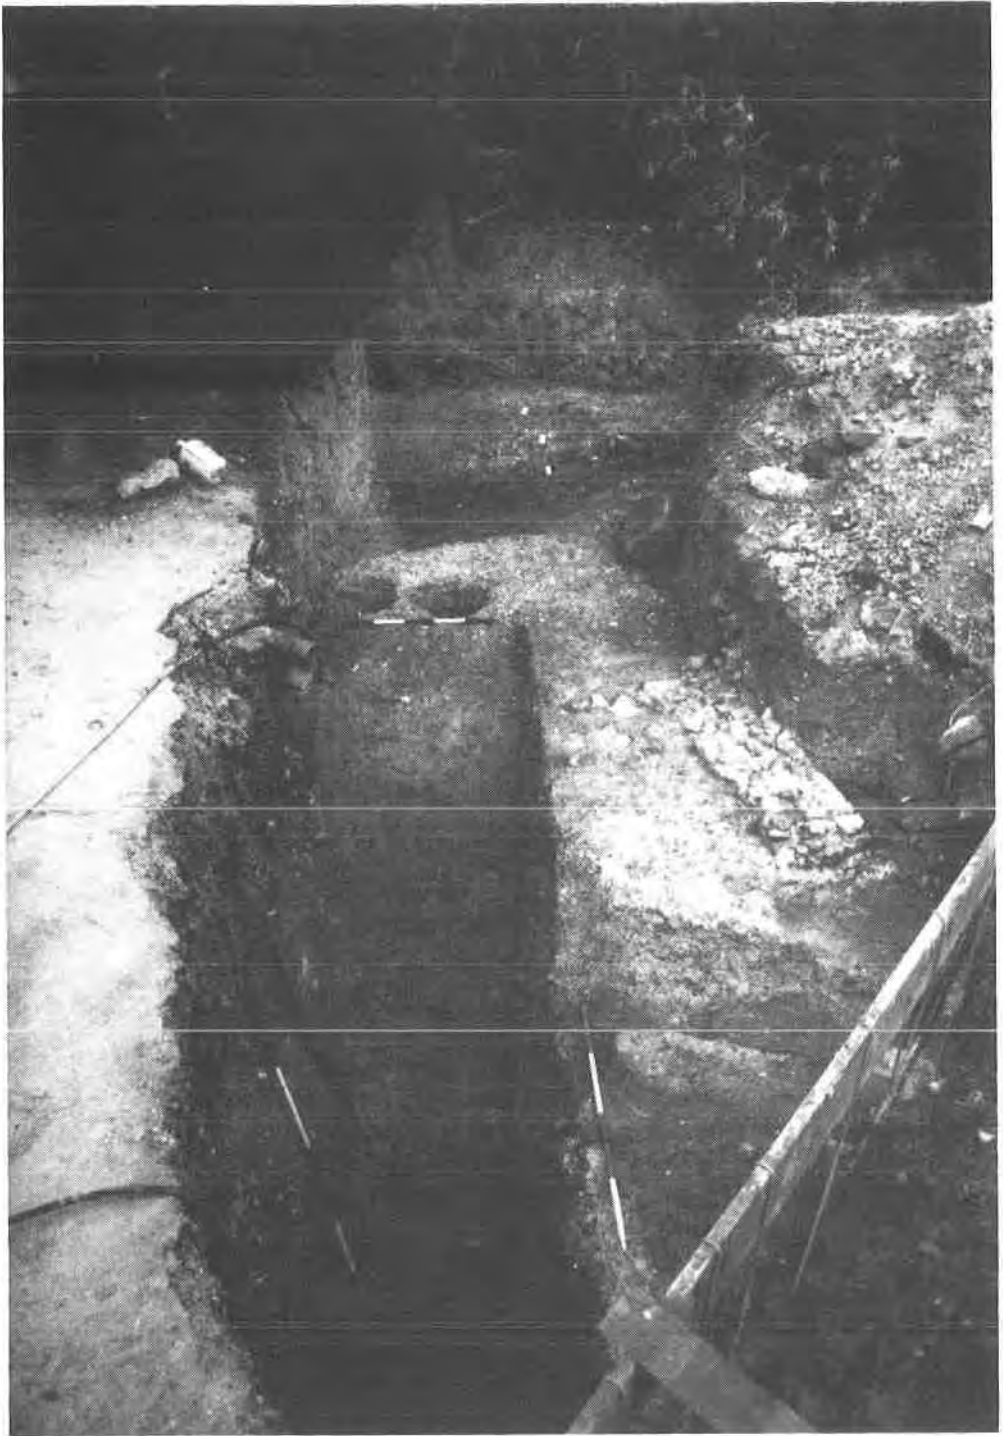
Plate XVIII. Section ditch and mound material, looking E.
