# THE ROOKERY, BISHOPSTONE, AYLESBURY: AN ARCHAEOLOGICAL BUILDING SURVEY

*A building survey was carried out on The Rookery, 102-104 Bishopstone, Aylesbury, Buckinghamshire, a grade II listed cottage constructed of witchert, a highly localised form of cob. The survey aimed to provide a record of the building in its current form, to investigate the structural development of the cottage and to attempt to date the various phases of construction and alteration. Structural evidence pointed to a seventeenth century date for the first phase of the building, although analysis and dating proved difficult due to extensive alterations carried out in the 1970s. Documentary evidence was of particular interest because it provided a link between this building and the current veterinary hospital in the town. The Rookery is a good example of a vernacular building, utilising highly localised witchert in its construction, and as such this survey may be of interest in any wider studies of this type of dwelling.*

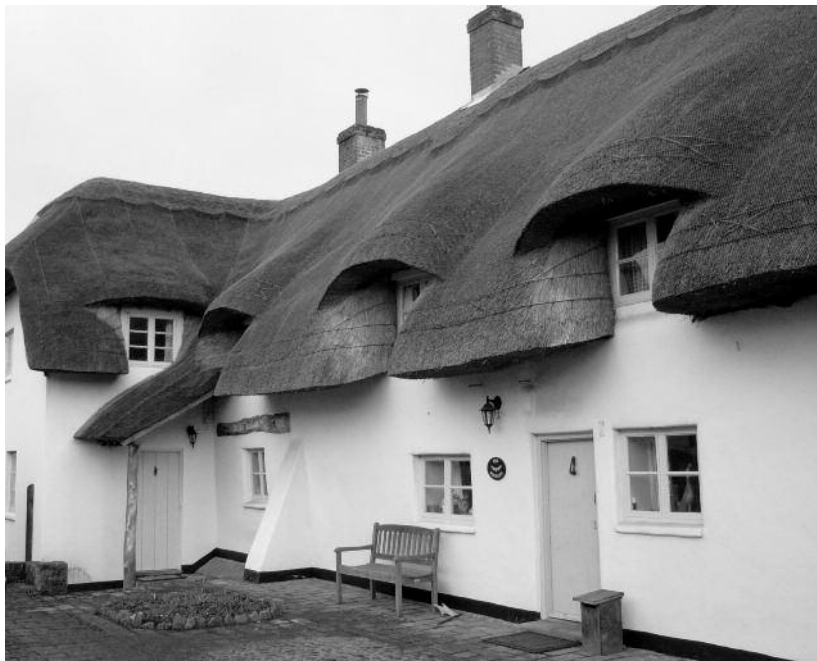
FIGURE 1 Eastern elevation

The current entrance is in the eastern elevation (Fig.1), which opens onto the courtyard drive, but there is evidence that the western elevation (Fig. 2) was at one time the front of the building, having two original dormer windows and facing the rest of the village. The 1925 title deeds confirm this, by showing pedestrian access on this side of the prop-

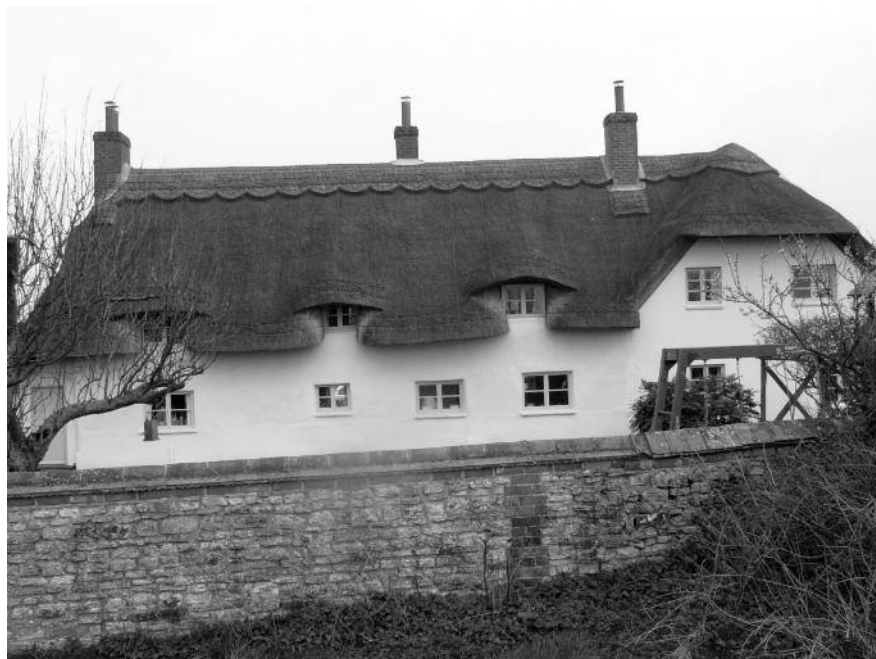
FIGURE 2 Western elevation

Another point of interest is that there is a solid wall between rooms 5 and 6 on the upper floor, with evidence in the roof space of an original gable end on the same alignment as this wall. This sheds light upon the chronological development of the building. The window in the western elevation of room 1 is set deeper than the others, within a reveal. There was at one time a door here, since removed, which would have served as the original main door of the house.

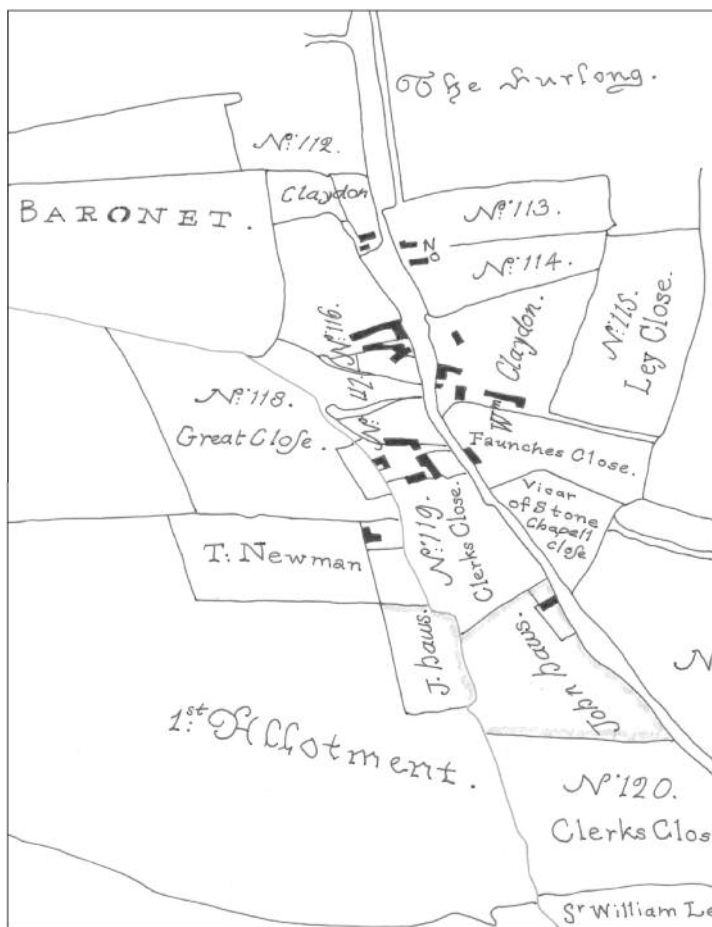
FIGURE 4 Tracing of 1776 enclosure map, showing a building presumed to be The Rookery, on land belonging to John Haws

A building on the current footprint of The Rookery can be traced back to the 1776 enclosure map (Ma 96/I.R. CBS), the land being annotated with the name "John Haws", suggesting that the property was in private ownership at that time (figure 4). This is confirmed by a document amongst the Lee Estate papers (D/LE/D.12, paper 45, CBS) which gives accounts for sums paid to landowners following the enclosure of fields in Hartwell and

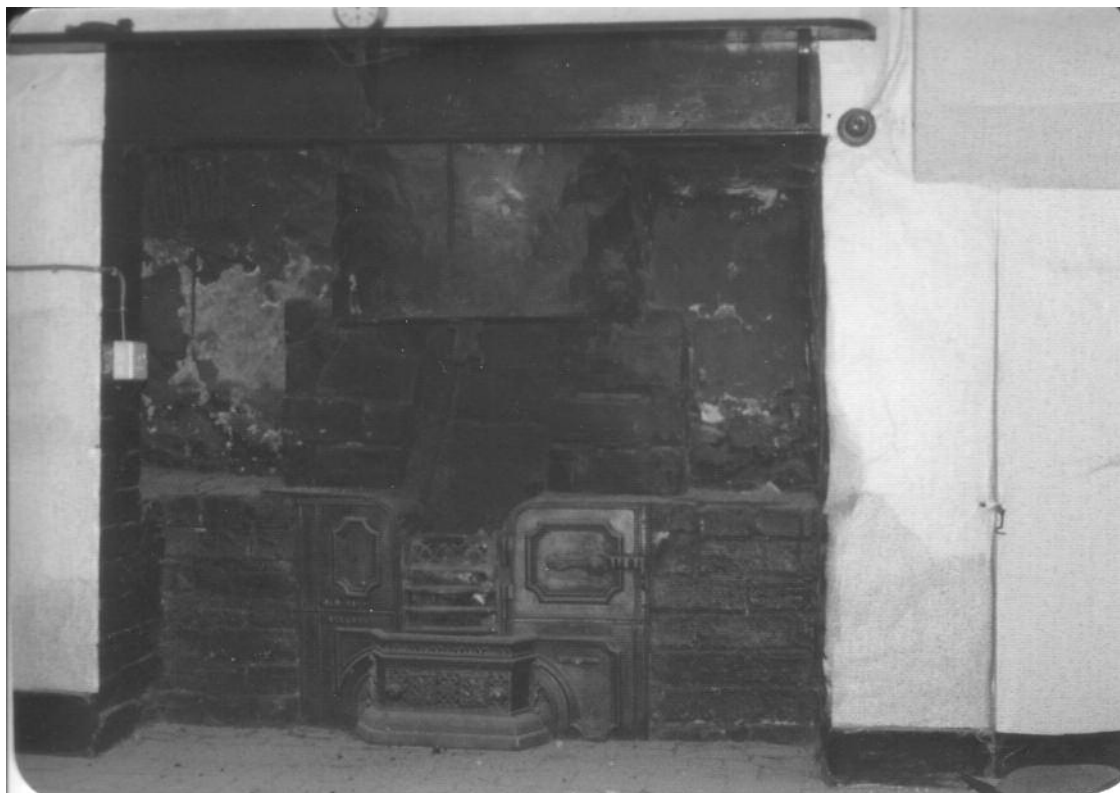
FIGURE 5 Kitchen range removed in 1975

gentleman who purchased the house in 1974, that the elderly man living in number 104 at that time used an old kitchen range for all his heating and cooking (Fig. 5), and had just one 15 amp socket feeding three light bulbs. Each of the cottages had a single cold water tap. Number 102 had a single outside privy on the western side of the property, which is still present; 104 had a two-holer privy attached to the barn on the eastern side (W. Fraser, pers. comm).

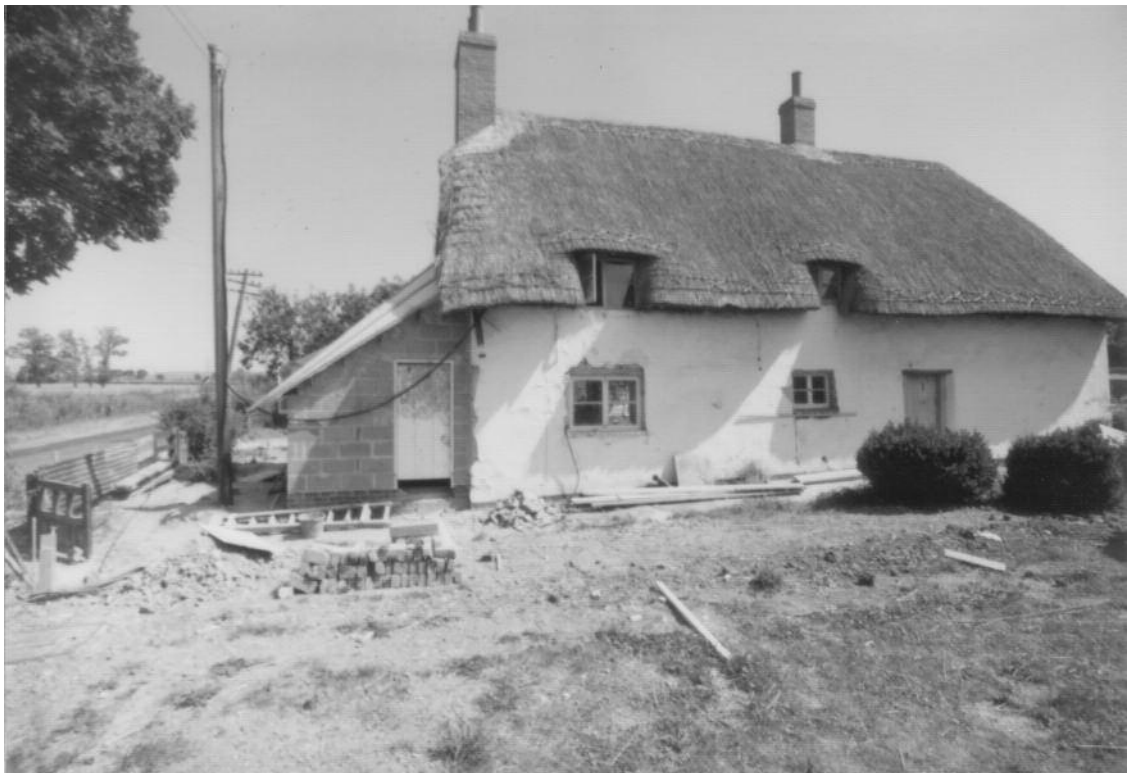
FIGURE 6 1970s photograph of western elevation

In 1975, the previous owner re-built the out-house to serve as a utility, replacing the northern brick chimney stack at the same time. Dormer windows were added to the eastern elevation and a third dormer added on the west. The original door in the western elevation of the witchert section was also blocked up, being replaced by a window. This effectively turned the orientation of the building to face east, instead of its original westerly facing aspect. In 1977, planning permission was granted for the construction of the southern cross-wing extension. This led to the blocking up of the windows in the existing southern gable end. Internally, the stairs in room 1 were removed, since access to the upper floor was now possible via the cross-wing staircase, in addition to the kitchen stairs (Figs. 6 and 7).

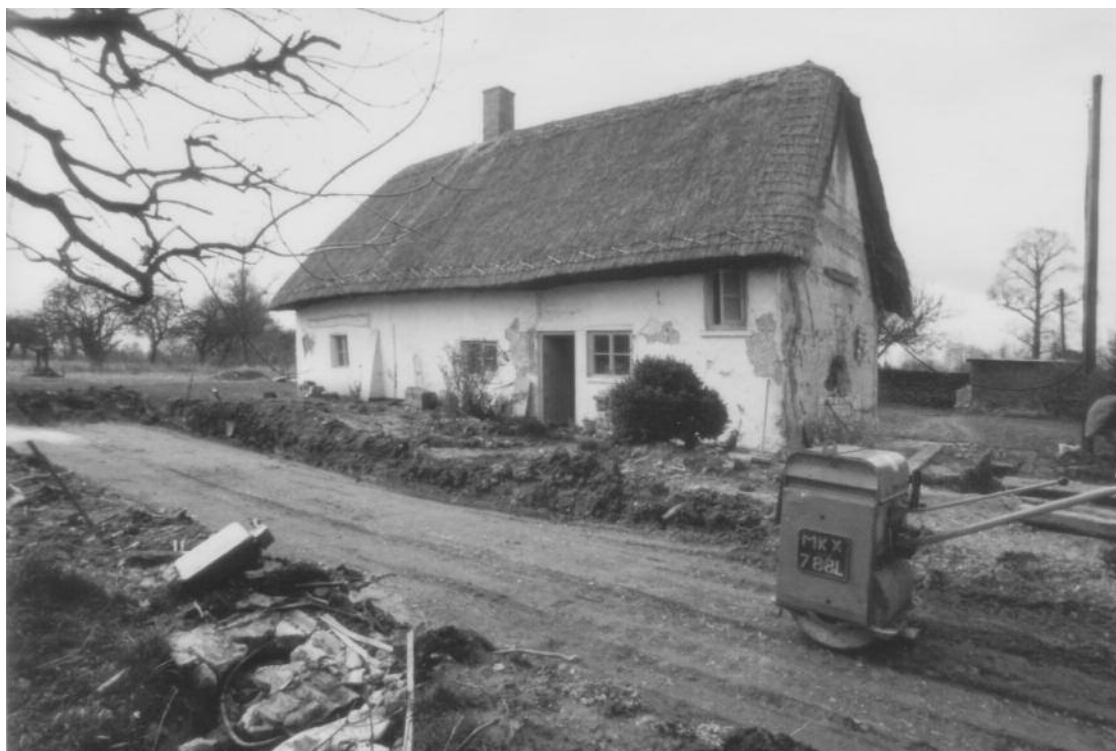
FIGURE 7 1970s photograph showing eastern elevation with brick out-house and northern chimney stack removed
