‘BAD BEDS AND WORSE EATING’ THE RESTORATION AND REVIVAL OF THE NEW INN, STOWE

GARY MARSHALL (National Trust Archaeologist)

In 2005 the National Trust acquired the New Inn at Stowe with the aim of restoring and adapting the dilapidated buildings to create a new visitor facility and garden entrance. Archaeological recording of the buildings commenced in the same year and continued as a watching brief during subsequent restoration works undertaken in 2010 and 2011. This article summarises the results of documentary research and archaeological recording undertaken since the inn’s acquisition. Construction appears to have commenced in 1717 and was almost certainly completed in the following year. Conclusive evidence for an earlier inn on the site has not been found: however, the buildings incorporate a number of re-used timbers, including a suite of roof timbers dating to c.1550. Major changes were made to the inn between 1782 and 1797, coinciding with a change in the dynasty of innkeepers responsible for its operation. The demise of the inn dates to c.1860, from which point it then operated as a farm leased from the Temple-Grenville family. It was sold into private hands in 1928 and

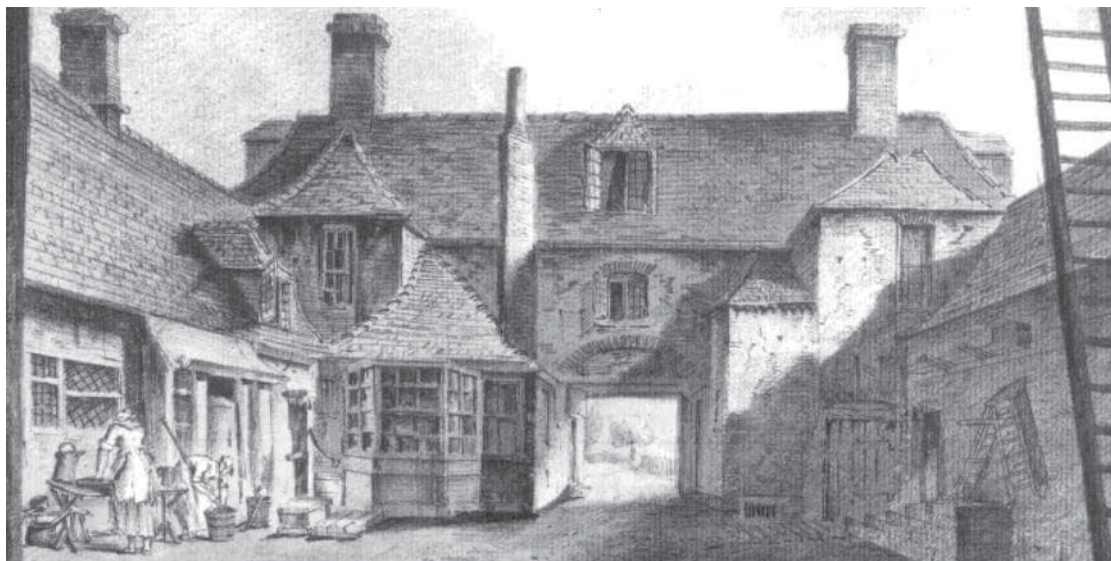
FIGURE 2 Engraving by J.C. Nattes, 1809: main courtyard looking towards the carriage arch

In 1800, the New Inn passed to William's nephew, George Bennett. Soon after a series of watercolour drawings of the house and gardens at Stowe were undertaken by Jean Claude Nattes; one of these, of 1809, shows the courtyard of the New Inn looking east towards the carriage entrance (Fig. 2, the originals are held by Bucks County Museums Service). The scene is enlivened by maids washing either laundry or dishes in the courtyard. From an archaeological point of view it is a valuable source as it shows the configuration of the buildings at this date, indicating that the two original stair towers attached to the courtyard elevation had been extended and the stairs reconfigured to form straight flights, as against the original winding form. The small 'office' or Tap Room with its bay window overlooking the courtyard had also been added by this date. Within the carriage arch the meat safe which can still be seen today is evident on the north wall.

Evidence from the 1809 Nattes engraving suggests that the original stair towers extended to the attic floor. The north stair tower still retains the top part of the staircase from the first floor landing (F10) to the attic. The original top section of the south staircase has been removed, though evidence for a blocked doorway leading onto it was found when part of the plaster was removed from the west wall of F6. The current southern access to the attic is via a narrow and inconvenient winding stair added to the southern face of the original stair tower. It can be seen on the Nattes engraving where the roof line shows a smaller additional pitched roof.

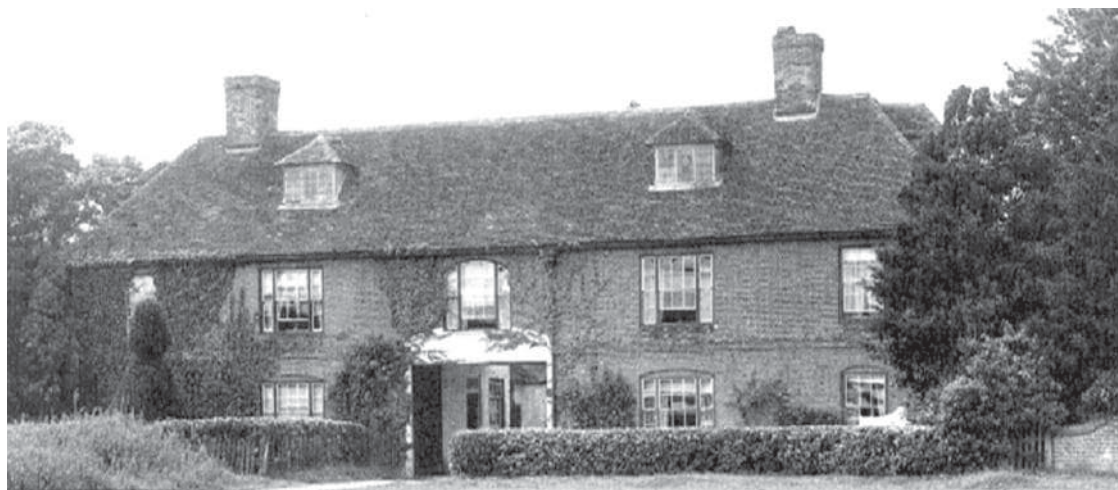
FIGURE 6 Early 20th century photograph of the front of the New Inn (source New Inn Conservation Plan 2008)

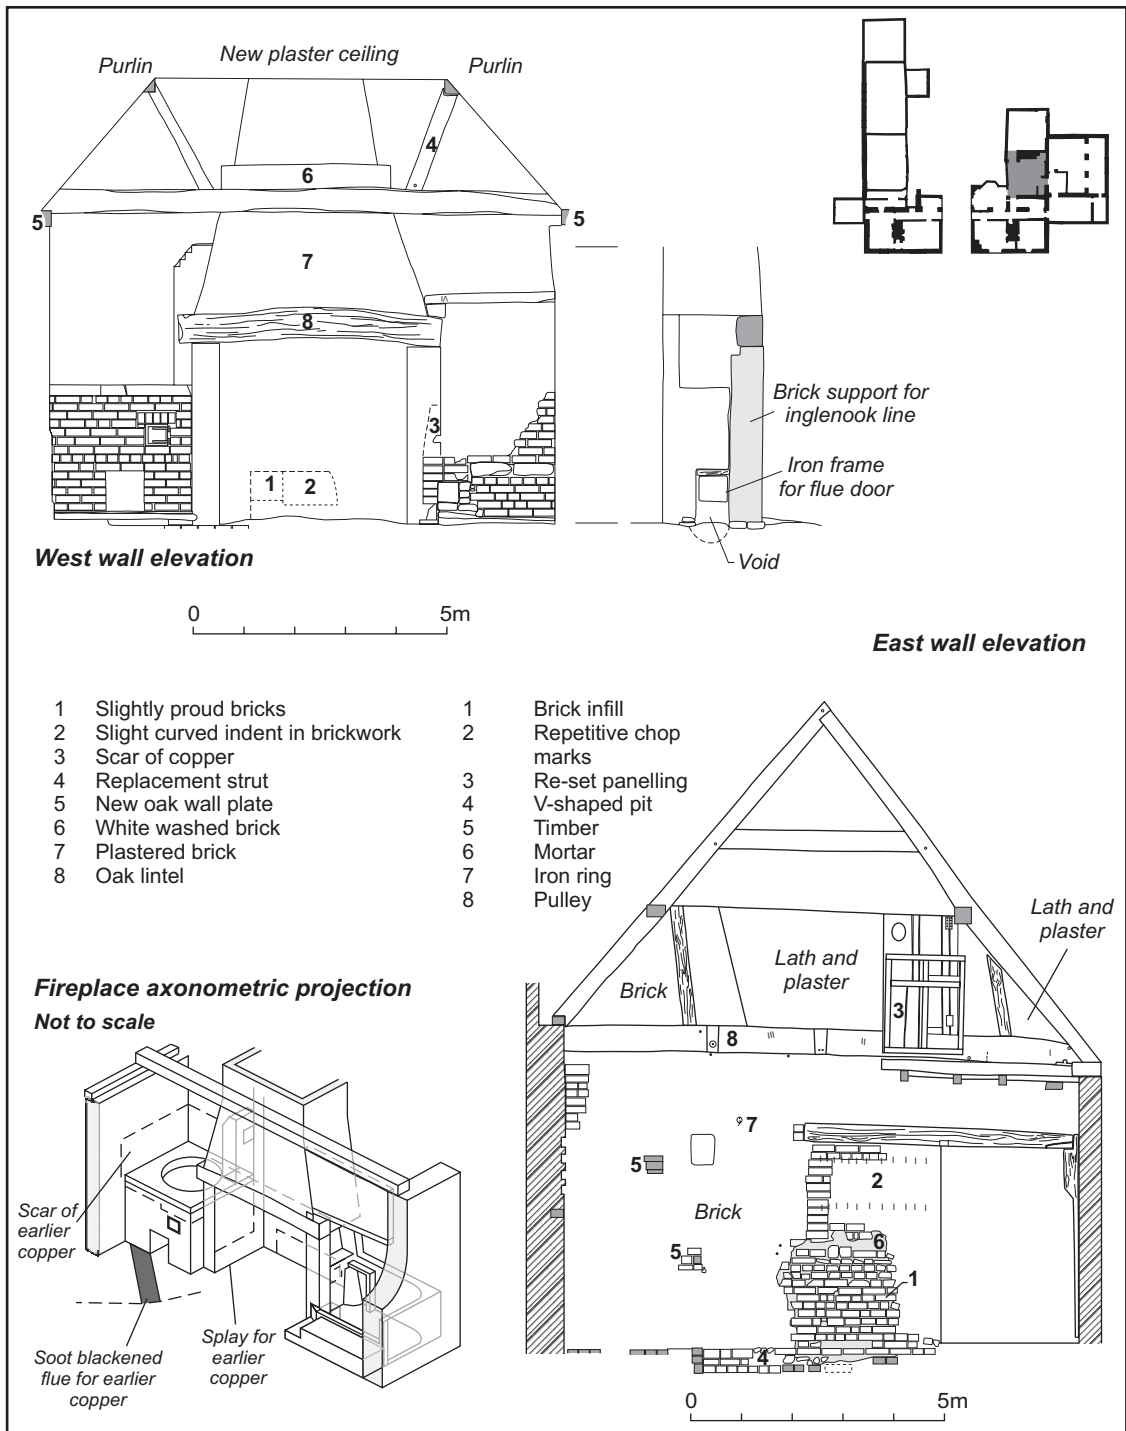
FIGURE 15 Elevations of the east and west walls of the dairy and axonometric view of the copper settings

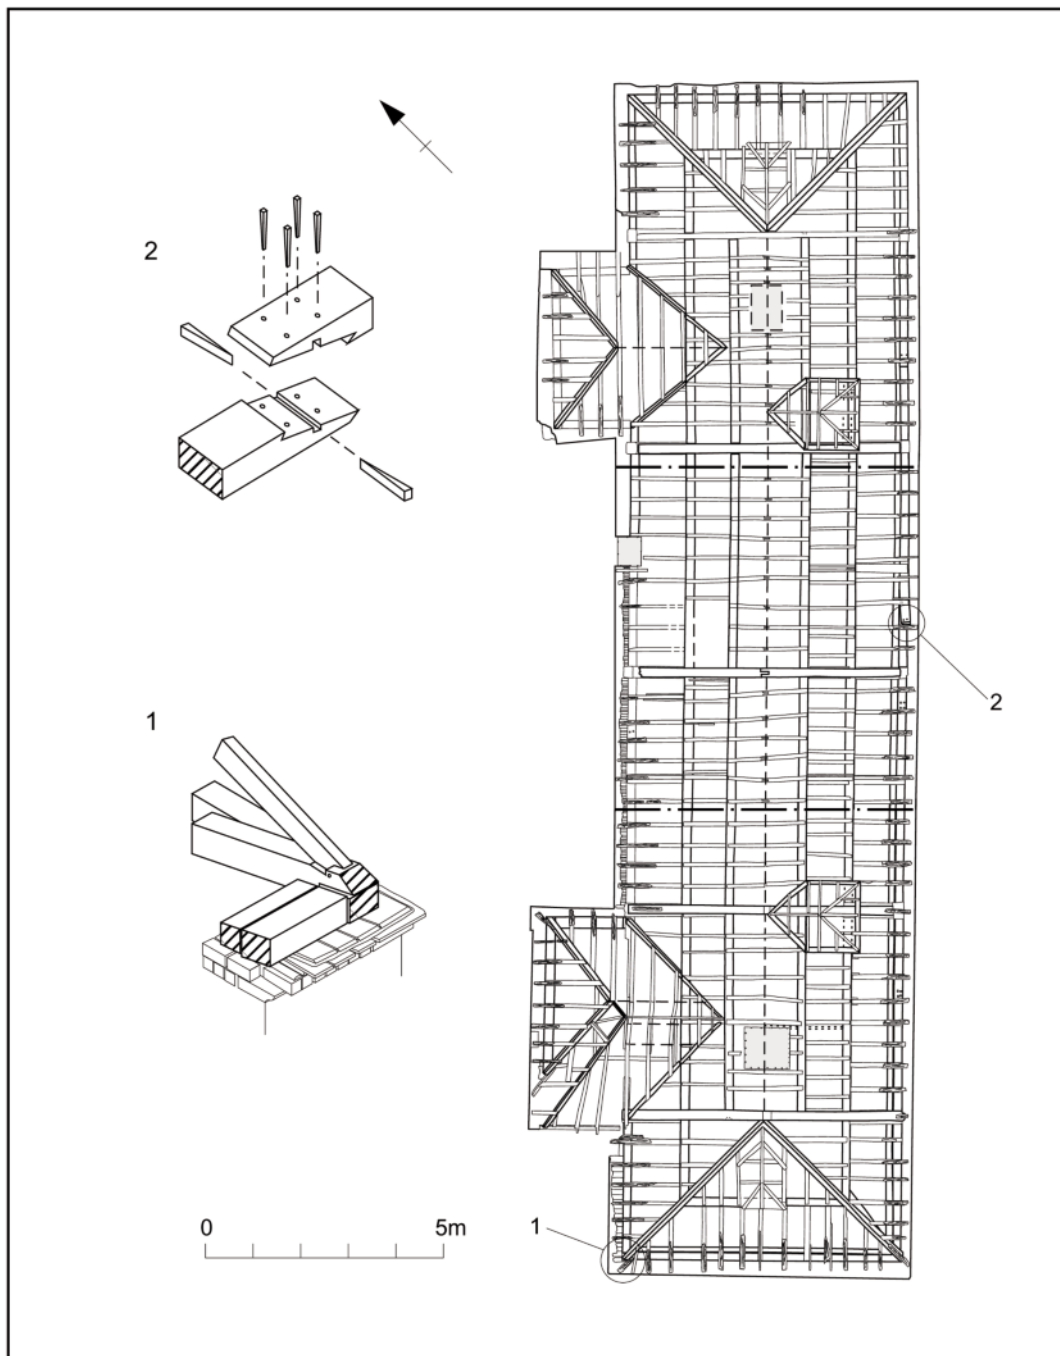
FIGURE 17 Plan of the roof framing of the east range

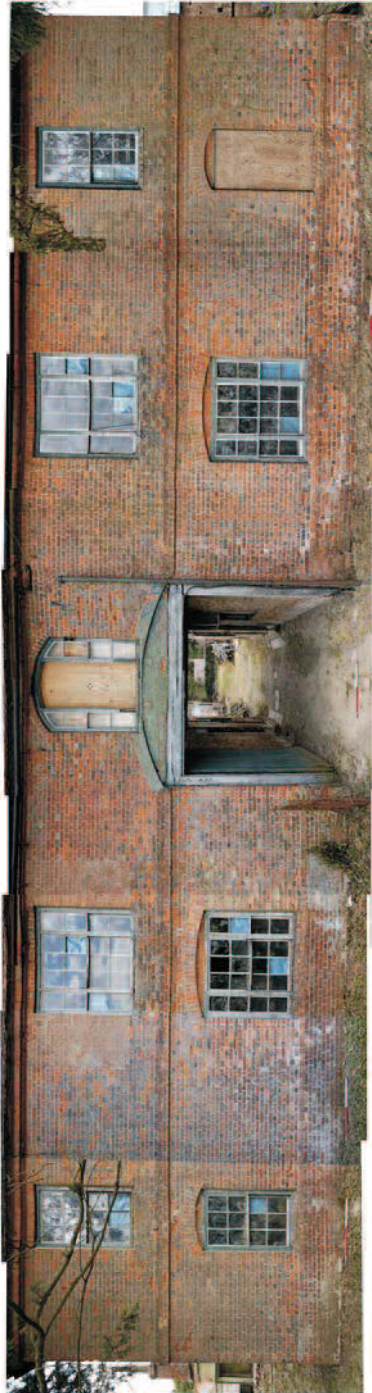
East (main front) facade

FIGURE 20 Principal elevation of the east range showing outlines of original window openings

The principal elevation of the east range has received considerable care in its construction (Fig. 20). The windows of the central and immediately-flanking bays represent later insertions, probably dating from the 1790s alterations when the parlours and principal bedrooms were reconfigured. The outlines of the earlier openings can still be detected, confirming that the parlours and bedrooms flanking either side of the carriage arch were originally lit by two separate sash windows,

rather than the single unit surviving today. These single units comprise three lights, the central light (12 panes) being an un-weighted sash reliant upon brass catches (rather than pulleys and weights) to take the weight of the lower sash and hold the window open. The flanking lights in each case (of 4 panes each) are similarly without weights but also lack the brass catches with which to lock the window open. The windows nearest both ends of the façade occupy the original openings, though the frames also date from the 1790s. They are identical in style but for their smaller size (12 panes only), lacking the 4-pane flanking sashes of their counterparts closer to the carriage-arch. In order to insert the current windows, the existing embrasures have been lowered by two brick courses and a new sill of moulded plinth-headers created. These sill bricks are probably reused items, taken from elsewhere in the complex, since some bear corner or edge damage which would be unlikely to occur in their current locations.

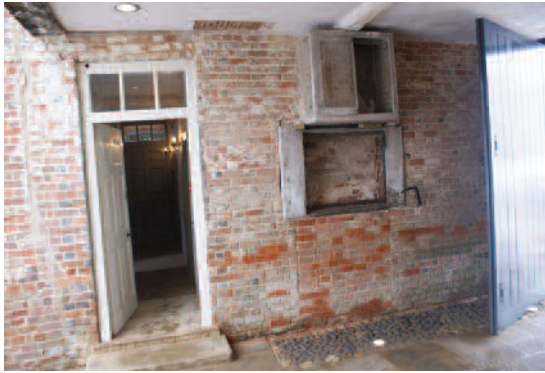
FIGURE 21 Carriage arch showing blocked original doorway to parlour G5 and meat safe

(G1 and G2) appear to have been higher status reception rooms which could perhaps be rented privately, whereas the two on the north (G5 and G6) were probably more communal, equating to today's public bar. The original centrally placed doorways leading directly into these parlours can still be seen

within the carriage arch (Fig. 21). They were probably blocked up in the 1790s when partitions were inserted into the parlours and new entrances created. This would have reduced the size of the parlours but would have helped to exclude draughts, increased privacy and separated the

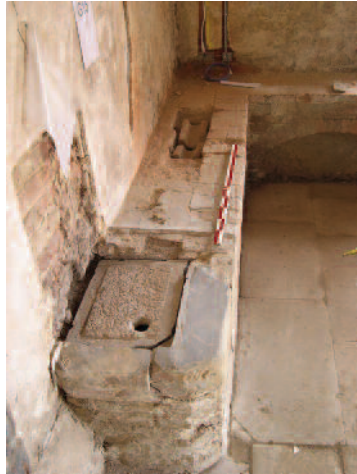
FIGURE 24 Remains of stone-lined sink and drain in the dairy

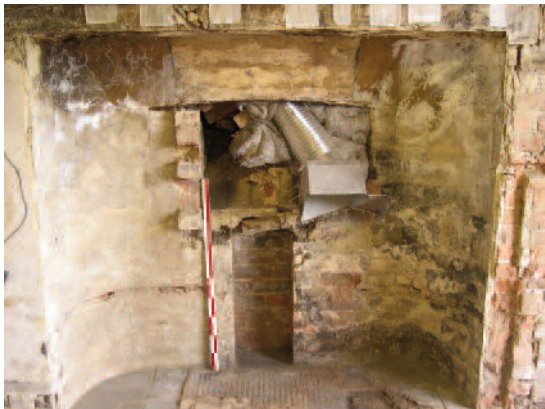
FIGURE 22 Parlour G5 fireplace showing false-jointed lining on 1790s plaster

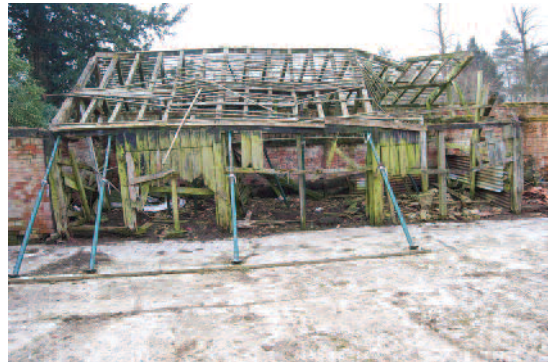
FIGURE 25 The animal shelter in the farmyard

The so-called animal shelter formed a lean-to structure against the south wall of the yard. This unremarkable (Fig. 25) structure resembling a shelter for livestock may have replaced an earlier

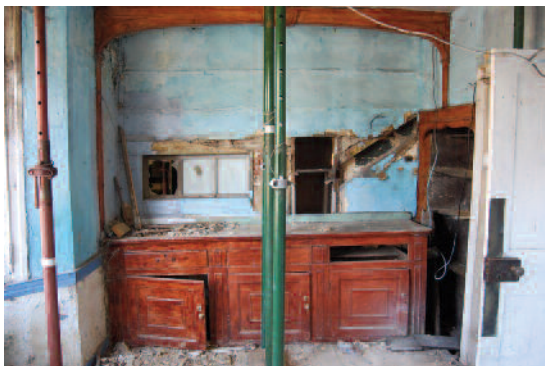
FIGURE 23 North wall of Tap Room G7

The north wall retains elements of the original timber framing of the north wall of the courtyard (Figs 11 and 23). A re-used window of three panes looking on to the kitchen was probably inserted when the tap room was built, allowing kitchen staff to see guests entering and leaving the room. The north wall also retains an unusual arrangement of diagonal timbers leading to a gap cut into the side of a cupboard facing onto passage G9. A thin piece of tin covers the gap. It has been suggested that this

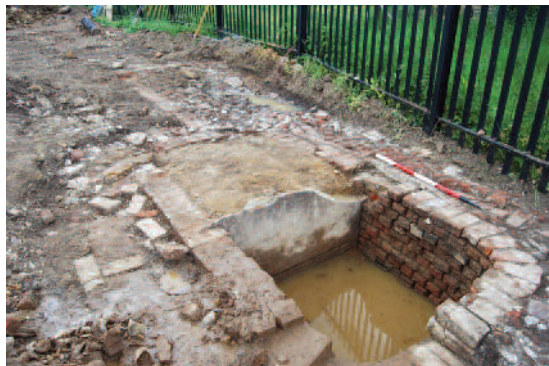
FIGURE 26 Brick-lined cistern in the western yard

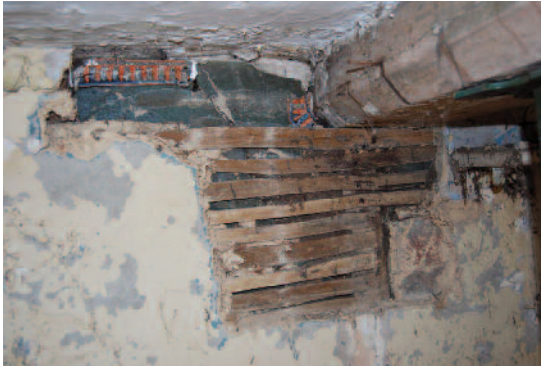
FIGURE 27 Remains of 1790s wallpaper in parlour G1

The historical changes to the layout and design of the New Inn have fortunately involved accretions and minor alterations to earlier structures, consequently significant evidence for earlier decorative schemes, including original paint colours and wall-papers, has been retained. In their original design the two southern parlours (G1 and G2) were painted to their full height in a light yellow distemper with a black painted skirting to a height of 0.25m. The elevation was broken up by a dado rail applied over the plaster. A later layer of lath and plaster secured to vertical battens had then been applied in these two rooms, evidently to combat problems of rising damp (Fig. 19). It is possible that this alteration was part of the 1797 repairs as these included '*plastering the Dining Room*' and '*Stoccoing the Paler*' (Reading University Buc 11/1/22). Removal of this later lath and plaster revealed a light blue paint applied over the original yellow with a greyish stony colour applied below a dado rail (Fig. 28), traces of which were suggested by horizontal 'tide' marks in the paint. As part of this paint scheme a narrow (40mm) border paper had been applied around the door frames, windows, cornice and dado in G1. Traces of this hand-printed paper decorated with tongues of orange and blue on a black background survived (Fig. 27) and have been reproduced to recreate the 1790s appearance of these two rooms. Narrow glue marks indicated that a narrow border paper had been similarly applied in parlour G2 (Fig. 28).

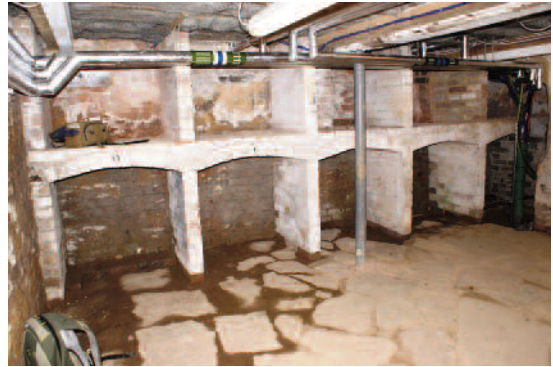
FIGURE 29 Wine bins in the south cellar retaining numbered bays

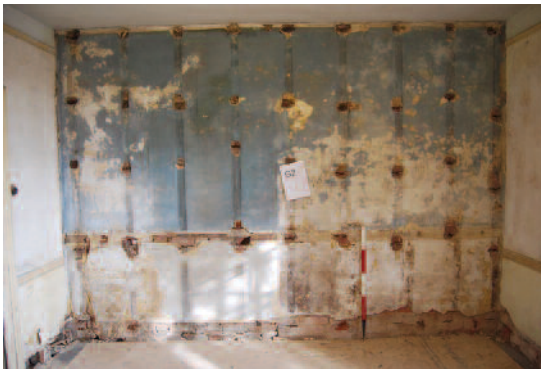
FIGURE 28 North wall of parlour G2 showing 1790s paint scheme

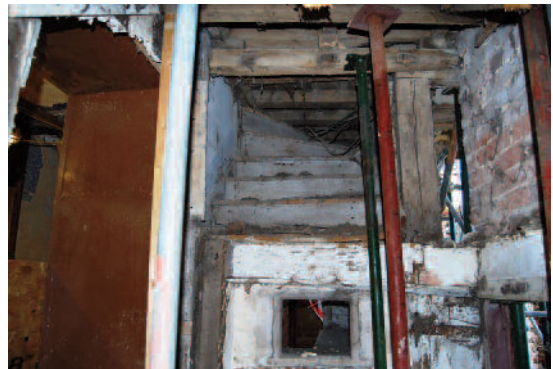
FIGURE 30 Original surviving treads for winding staircase in the southern tower

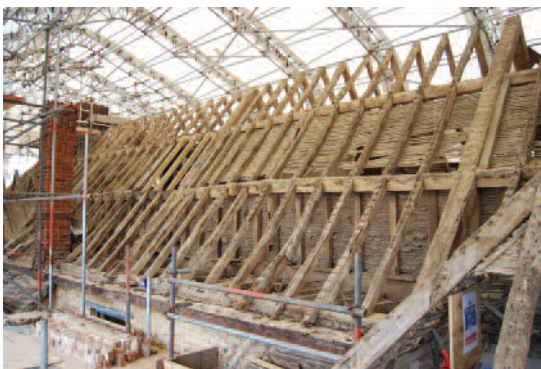
FIGURE 31 East range of the roof (looking north) after removing the tiles

Each of the pitches incorporates a ridge-plank, while iron bolts have been used in the past to strengthen many of the principal joints around the roof. To both east and west there are timber remains which suggest a dormer window may have been

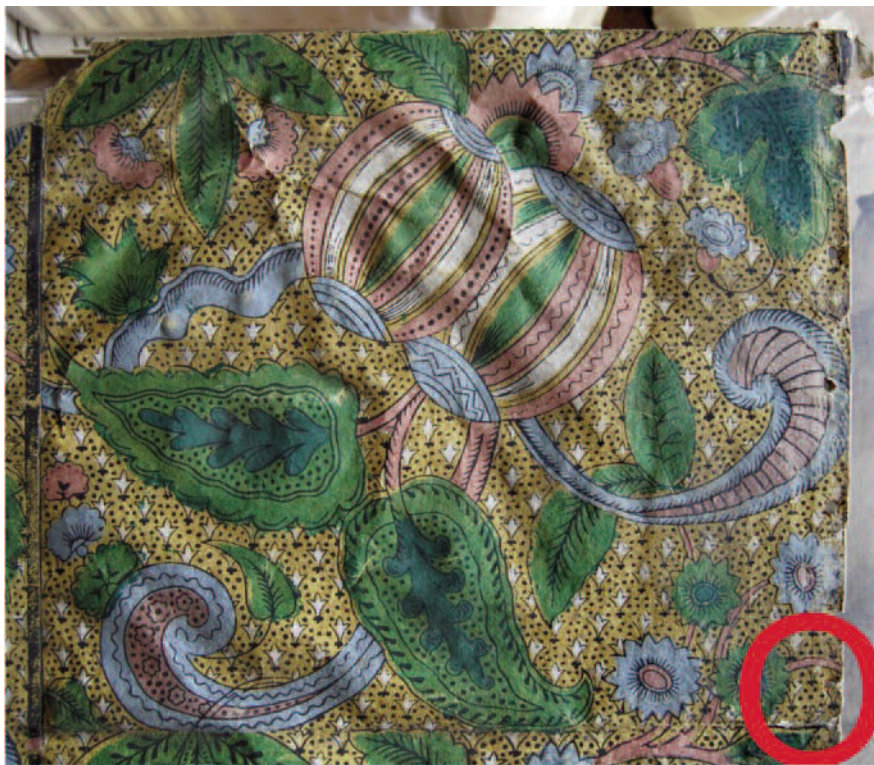
FIGURE 32 *c.*1720 wallpaper from Erdigg with red circle illustrating location of New Inn fragment

of their concealment behind later layers of lath and plaster or behind applied skirtings and dado rails. The walk-in cupboard in F14 has a number of significant early 19th century wallpapers: these are no doubt end rolls as they can be traced elsewhere in the building. The earliest paper is a fragment of a block-printed paper found beneath one of the attic floors. It is decorated with an intricate floral pattern embellished with pomegranates and probably dates from 1715–20. It is not clear why it was introduced to New Inn, especially as it was found beneath what were probably servant's quarters. Only two other examples of this pattern are known to exist, including a complete sheet at Erdigg in North Wales (Fig. 32). Papers of this period were printed on single sheets, at considerable cost, and were often reused as they were attached to the walls with tacks rather than glue. A second early paper found in F6 dates from the reign of George I or II (1714–60) as it carries a tax stamp. One of the fragments from cupboard F14, dating from *c.* 1800, has
