SHELL HOUSE, HEDGERLEY: A DENDROCHRONOLOGICAL POSTSCRIPT

A LOST MONUMENT AT HORTON CHURCH

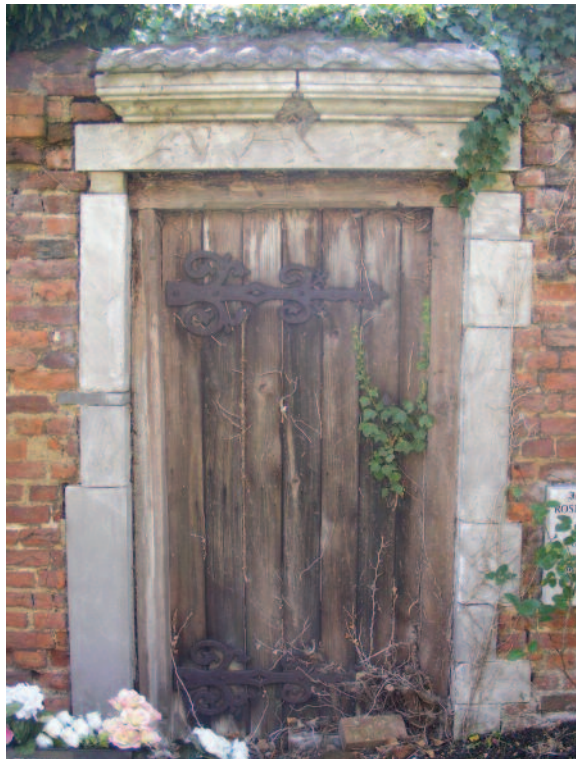
FIGURE 1 Doorway in the churchyard wall at St Michael's church, Horton, general view (Photo, author)

A few years ago the scanty architectural remains of a monument were identified by Michael Farley as built into a doorway in the churchyard wall of the Parish Church of St Michael at Horton, near Colnbrook.¹ The moulded elements, arranged decoratively above the marble lintel block of the opening, consist of two identical moulded architectural fragments in white marble, and a long black marble gadrooned element. The jambs of the opening are also made from narrow marble ashlar blocks, possibly from the same source (Fig. 1). One of these blocks had incised lettering, although the wording could not be deciphered. A quick survey of the surrounding walls by this writer found no

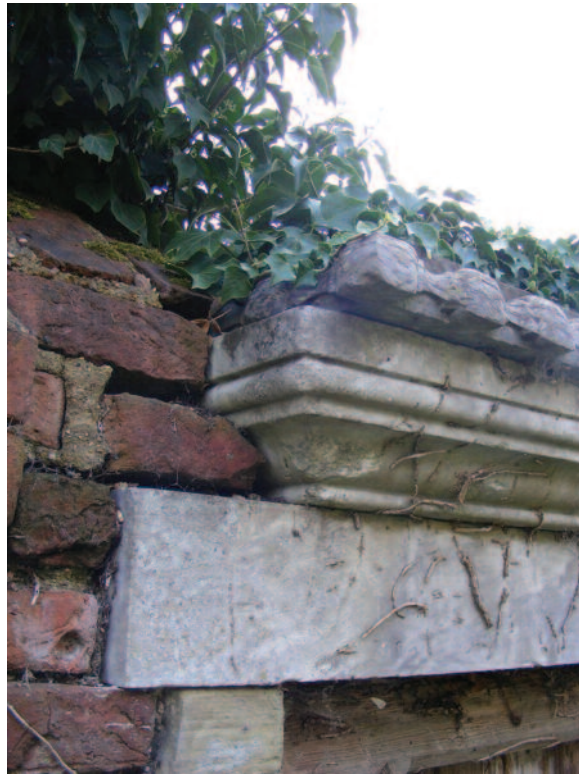
FIGURE 2 Doorway in the churchyard wall at St Michael's church, Horton, detailed view (*Photo, author*)

further marble elements, although small fragments of moulded Portland stone were found lying loose within the churchyard. The identical white marble elements above the lintel are moulded plinths or bases of pedestals of the Corinthian order, with the modification of an added torus, approximately 0.605m wide, 0.14m high and at least 0.14m deep.² Based on contemporary principles of architecture the pedestals they supported would have been approximately 3ft 3in (98.1cm) high. The black marble gadrooned element is 1.2m long and at least 0.23m deep – the gadrooning wraps around the sides of the block – and has upper and lower mouldings (Fig. 2).

elements from the churchyard doorway: the two moulded Corinthian plinth/base elements may derive from the outer, recessed sections of the tomb-chest but might be happier as pilasters or column-bases above these sections, set against the wall to form part of an architectural backdrop enclosing the upper part of the monument. The gadrooned fragment is most likely to form either the base or part of the body of the sarcophagus which stood on top of the central part of the tomb-chest, a typical arrangement as seen in a number of designs, including those published by the architect James Gibbs in the late 1720s.¹² However, Lipscomb's description is ambiguous as to the relationship of the sarcophagus, urn and pyramid; the latter may have either sat on the sarcophagus as a narrower form of pedestal or needle supporting the flaming urn, or formed part of the reredos-type architectural backdrop behind the sarcophagus and urn – in which case it may well have been a wide-based 'triangular' element.¹³ Of these the former design is by far the rarer, a much embellished example being the monument to the exiled James II of England, erected in the Collège des Écossais in Paris in 1703, and to James 3rd Viscount Scudamore (d. 1716) at St Cuthbert's Parish Church, Holme Lacy (Herefordshire), the latter design is more common, being used with or without effigies and architectural surround. The colouring of the pyramid, of black and gold, suggests its surface was decoratively carved, and may support the second suggestion.
