The Lodge, Doddershall

HISTORIC BUILDING REPORT / December 2013

including HS2 high-speed rail line impact assessment

Report number
BAS/2013-04

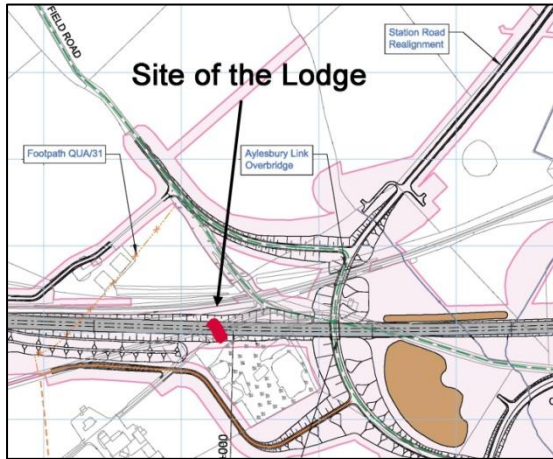
The route of the proposed HS2 high-speed rail line between London and Birmingham, as on the engineering plans accompanying the HS2 Environmental Statement of November 2013,³ takes the line directly through the site of the Lodge in order to run parallel with the existing track of the former Great Central line.

If the HS2 plans go ahead, this will result in the complete destruction of the Lodge.

Figure 2 (left): The HS2 engineering plan showing the line passing directly through the site of the Lodge.

If the construction of the HS2 rail line goes ahead as planned, the Lodge will be demolished. The survey recommends, as a minimum, the rescue of its historic features and fixtures.

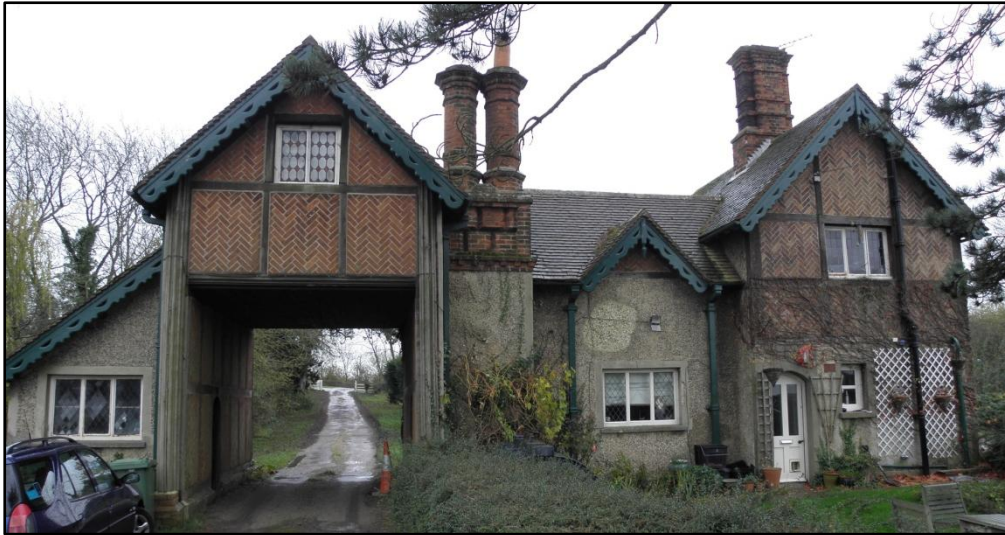
*Figure 7:
The western
elevation of the
Lodge.*

The central bay here has a single three-casement window matching those noted on the east front. Here, however, there are diamond leaded lights in the two outer casements with a single large pane between them (probably a replacement). Failing render on the right-hand side of this window has revealed a small area of brickwork, set in lime mortar.

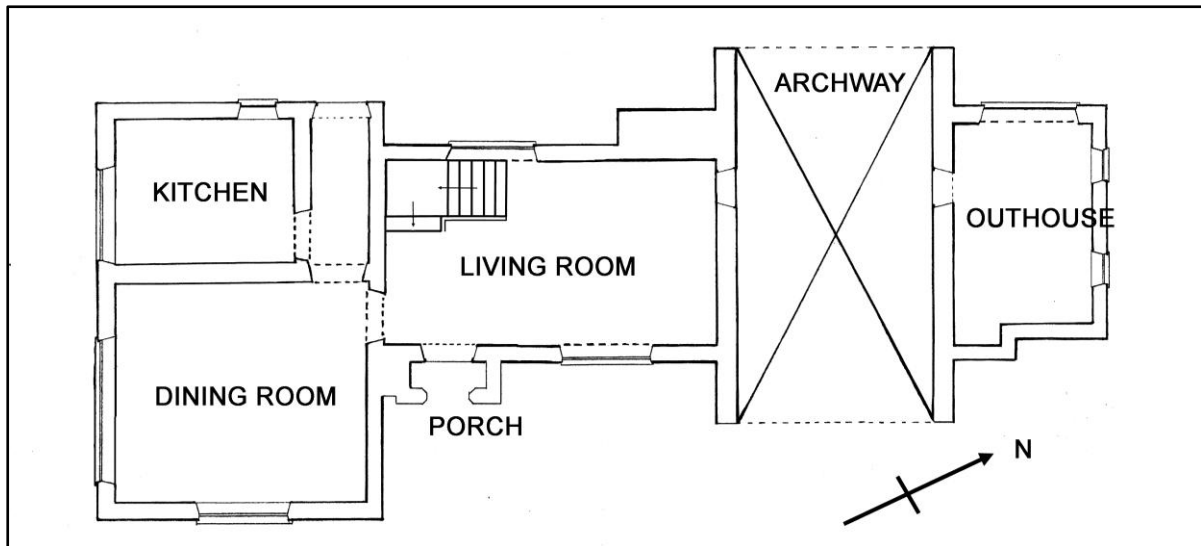
Figure 8: The ground-floor plan of the Lodge

From the dining room a doorway with four-centred arched top leads into the living room, in the central bay of the building. Above the doorway is a large jagged crack in the plastered wall.

The south wing is therefore a later extension. The jagged cracks above the connecting doorways on both ground and first floors show where these have been broken through and weakened the wall.

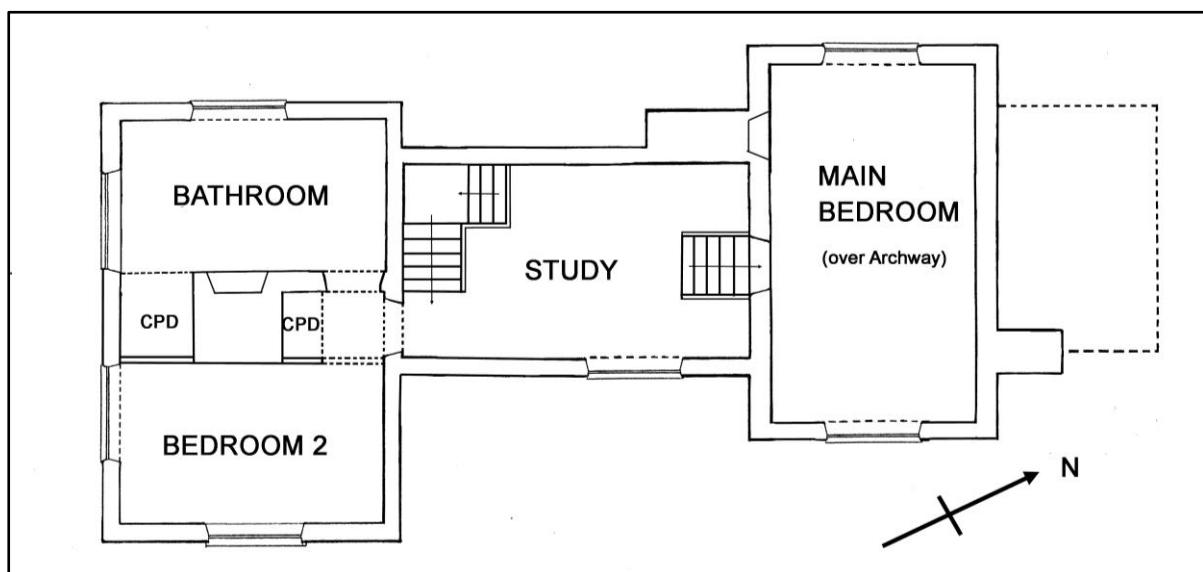
Figure 11: upper-floor plan of the Lodge.

Here again two purlins run the length of the ceiling. Again there is a heavily moulded tie-beam matching in profile that in the study and the posts of the driveway arch. Here, however, the purlins appear to rest on the beam, although they are not jointed into it. The beam's structural function is again difficult to judge.

Above this doorway is another jagged crack in the plaster wall, in a similar position to that above the doorway between dining room and living room immediately below on the ground floor.

Another example can be seen in the heavily moulded, black-stained beams on the upper floor which share the same moulded profiles as the pillars. The disjunction between these beams and the purlins of the roof structure indicates that these too are more decorative than structural. They may have been inserted after the roof had been built.
