REMAINS OF FORMER CHURCH AT
 CHALFONT ST. PETER
 By E. CLIVE ROUSE

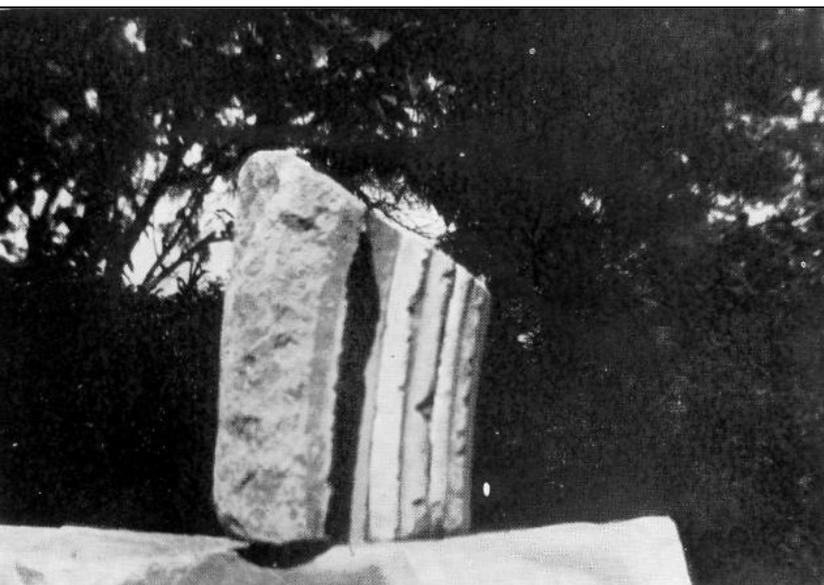
FIG. 1

Fig. 1 and Fig. 2 show the same piece from different angles (Section, Fig. 7, No. 1). It is part of an arch, and consists of well-cut mouldings, ogee and elliptical hollow, or cavetto. The stone is different from most of the others, and appears to be a whitish limestone

or hard chalk, the remaining specimens being of Totternhoe stone. This piece evidently came from a doorway, probably from the porch into the Church, as it is not weathered, and must have been easily reached from the ground, for it is cut and scratched, the date 1604 being roughly cut on the inner surface. Several of the other pieces have similar mouldings, but none is in quite such good order. The date is probably c. 1400.

Fig. 6 (a) is another arch moulding. It has either been re-cut or mutilated at some period. It is similar to Figs. 1 and 2, XVth century (Section, Fig. 7, No. 2).

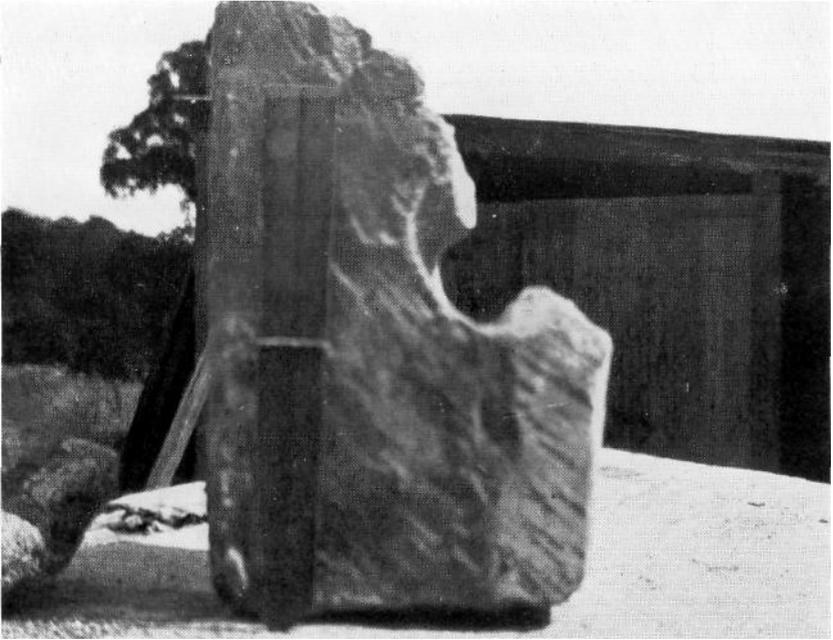
FIG. 3

Fig. 3 and Fig. 4 (a) show another piece from different angles (Section, Fig. 7, No. 5). It is one of the largest pieces, and is about the only one that is not curved. It appears to be a base moulding of a door jamb, deep cavetto and shallow ogee, and may have come from the outside of the porch, West door, or other outside doorway, as it shows signs of previous weathering. This again is Perpendicular, about the beginning of the XVth century.

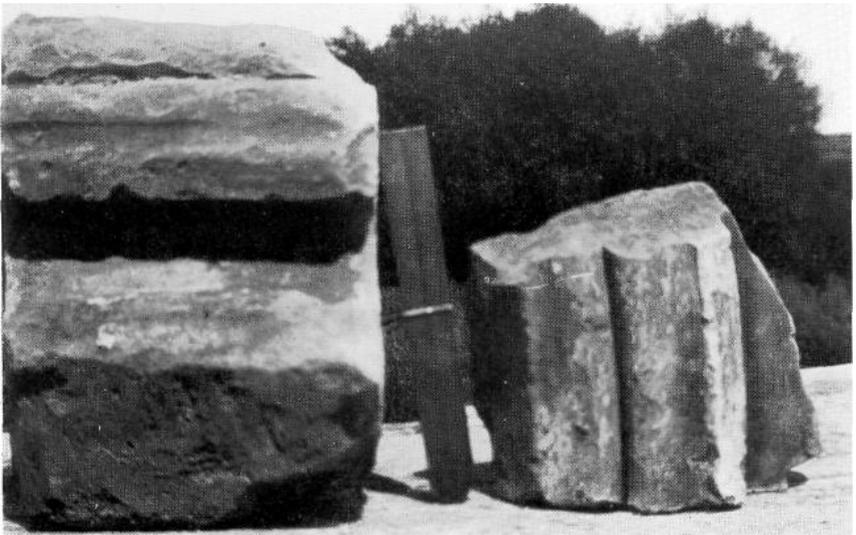
FIG. 4

Fig. 4 (b) is a fine fragment of a door moulding, bold double ogee and fillet (Section, Fig. 7, No. 7). I considered it probably late Decorated, c. 1370, but the authorities I consulted were divided on the question: so, taking the average, one may date the piece c. 1380 to 1400.

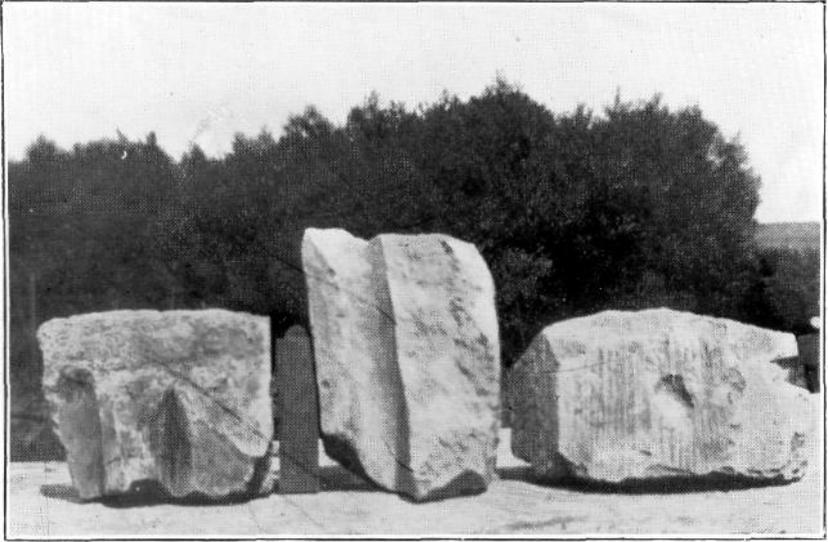
FIG. 5.

Fig. 5 (a) appears to be a fragment of a door moulding similar to Fig. 6 (b) (Sections, Fig. 7, Nos. 9 and 8 respectively). It is of earlier character than the others, and may well be Decorated c. 1330-1350.

Fig. 5 (b) is another fragment of a door or window moulding, and consists of shallow hollow and fillet. Too broken to classify accurately, but probably XVth century (Section, Fig. 7, No. 6).

Fig. 5 (c) is a plain chamfered arch segment: there are one or two of these pieces. XVth century (Section, Fig. 7, No. 4).

There are also pieces of XVth century window mullions, badly weathered. With the exception of Fig. 5 (a) and 6 (b), there are no fragments of the early date (1350) assigned by the Rev. F. H. Woods to the pieces he records in 1900.³

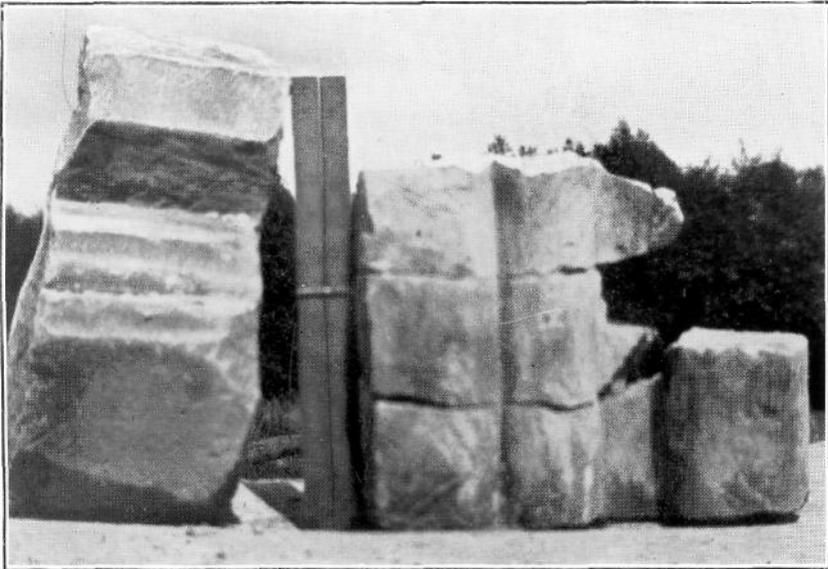
FIG. 6

Fig. 6 (b) shows three of the earliest fragments found (Section, Fig 7, No. 8). The top two pieces

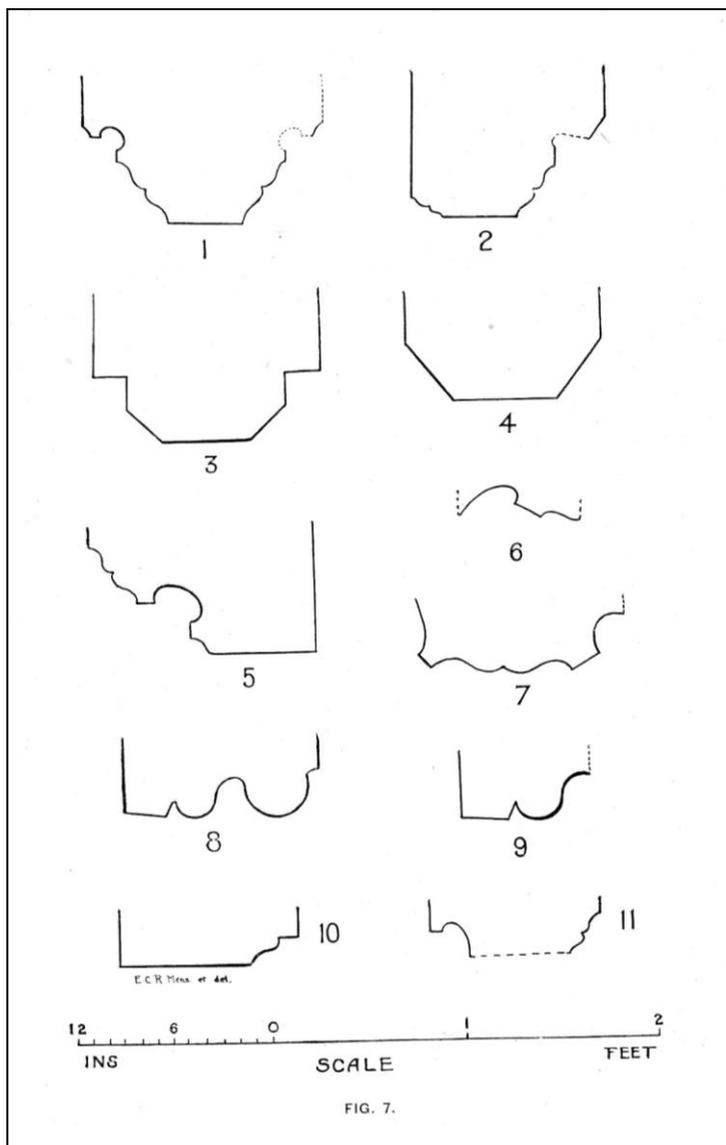
Of the pieces not illustrated by photographs, but shown on the sheet of sections (Fig. 7), No. 3 is a large arch segment with plain chamfer moulding. It is XVth century, and was on the outside of the Church, to judge by previous weathering.
