NORTHEND FARM HOUSE, LONG CRENDON

GUY BERESFORD

SUMMARY

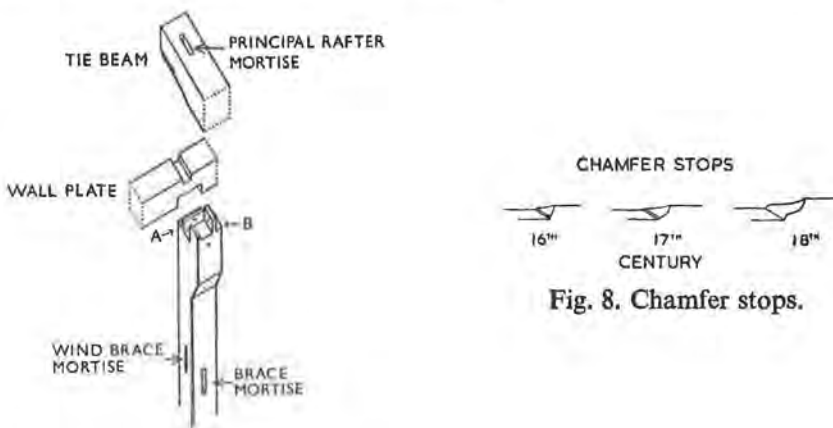
Fig. 7. 17th century angle post.

Fig. 8. Chamfer stops.

The joining of the wall plate, the tie beam and a principal rafter to an angle-post is illustrated in Fig. 7. The wall plate was housed above the angle-post and mortised on to the tenon marked "A" on the diagram, so that the top thereof was level with the base of the tenon marked "B". The tie beam was mortised on to the tenon marked "B" and was grooved and tongued into the wall plate. The principal rafter was tenoned into the tie beam.

The elm axis joist, 12 in. in width and 12 in. in depth, were chamfered and finished with scroll stops (Fig. 8). The joists were of the same wood. They had been covered with lath and plaster from the time of their erection. The oak boards of the first floor chamber were 11 in. wide and three quarters of an inch thick. They were not halved together.

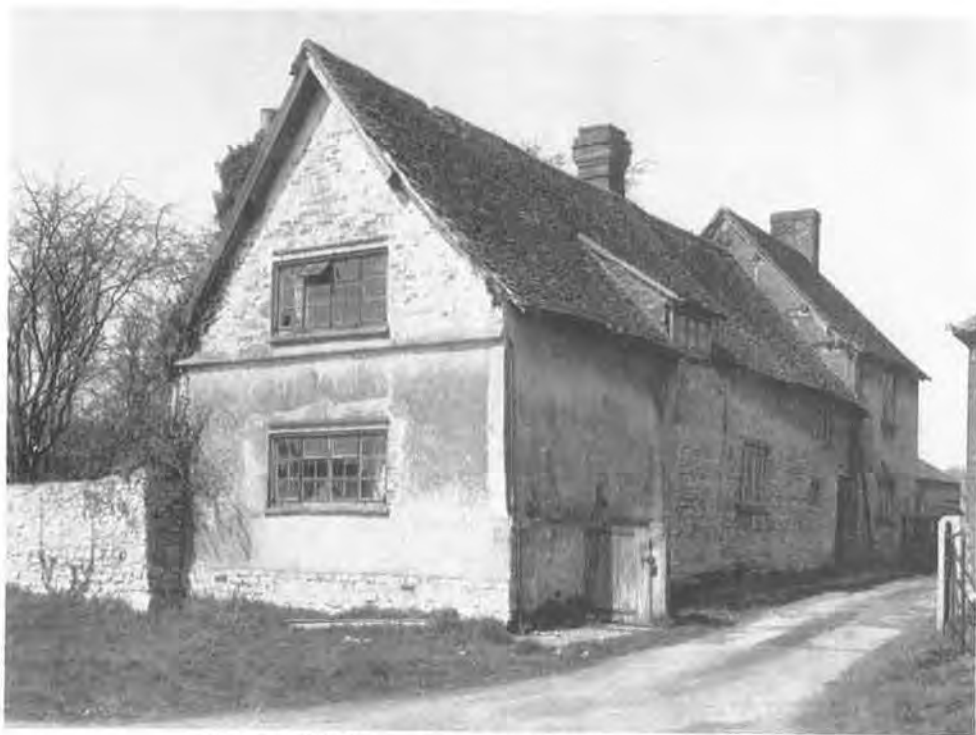
PLATE I (a). House photographed from south east.

In the second half of the 16th century, the medieval hall was reconstructed under the original roof. The east and west walls (Fig. 5, Plates Ia and Ib) were replaced with stone to the level of the first floor—which was inserted during these alterations—and brick to the eaves. The walls, 18 in. thick, were built of

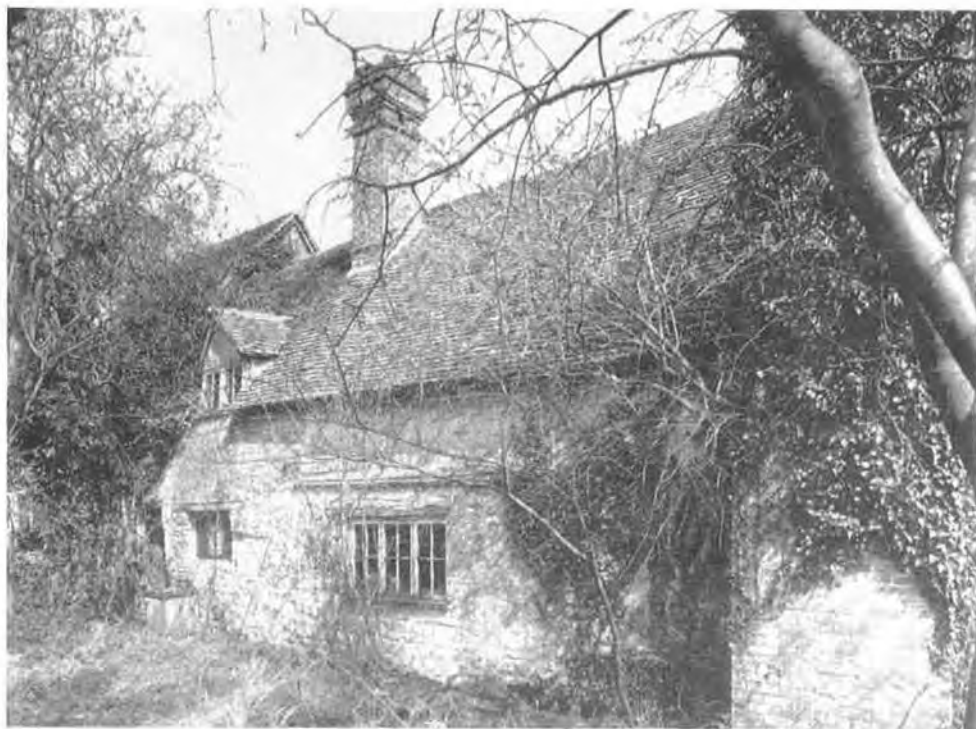
PLATE I (b). House photographed from south west.

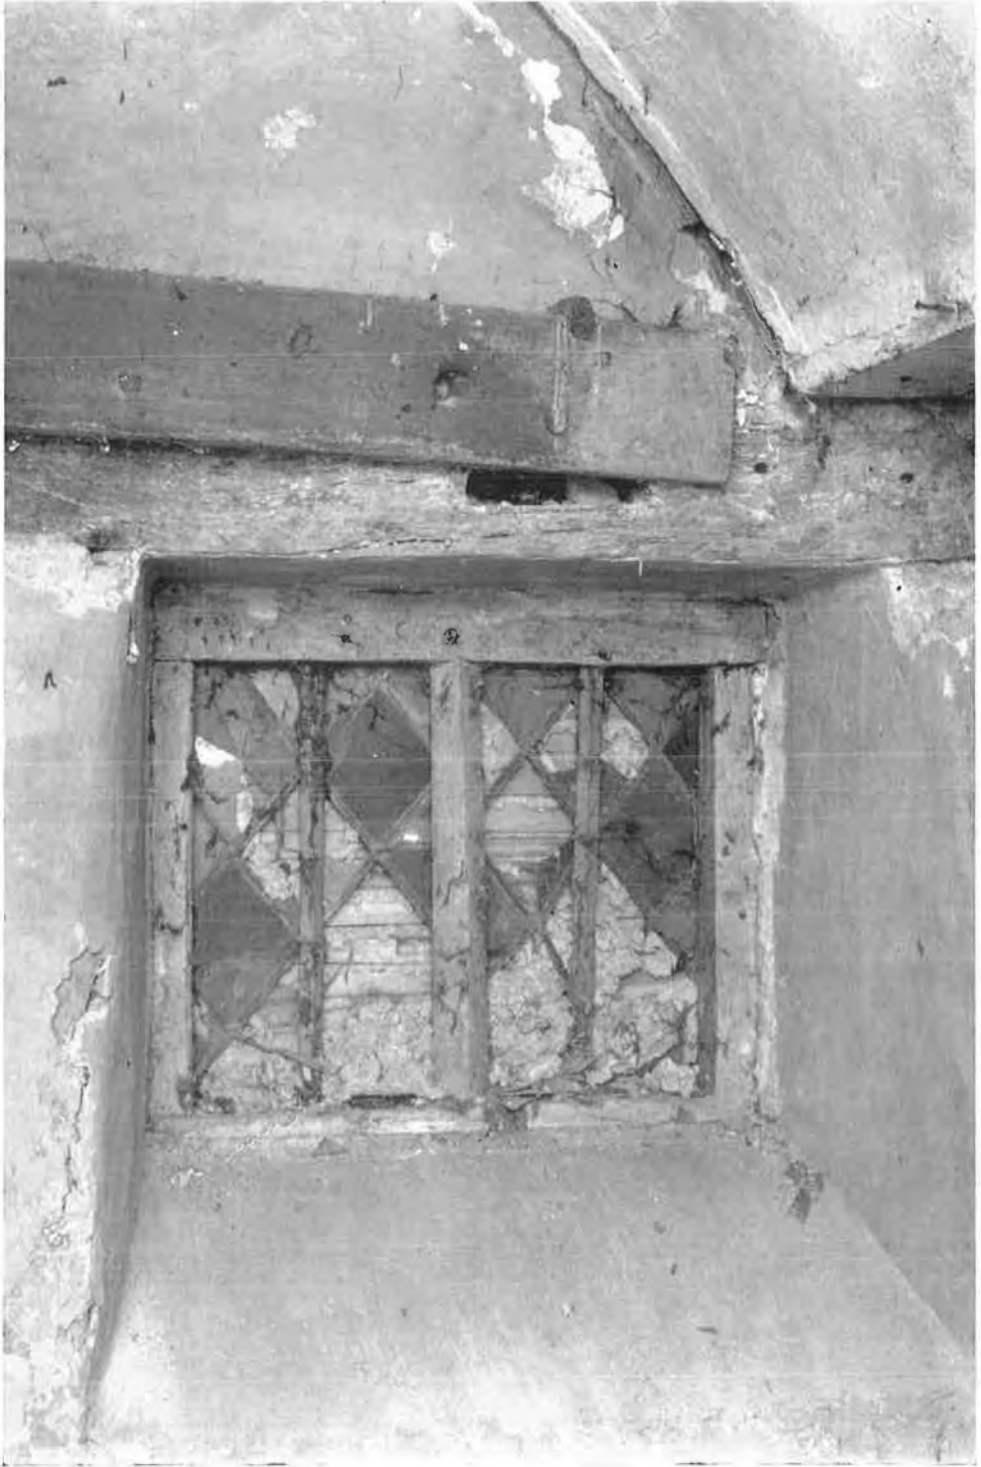
PLATE II. 16th century window,

The blocked window (Plate II) in the Eastern wall, situate on the South side of the door, was the only window of this period to survive. The others were replaced during the 18th and 19th centuries.

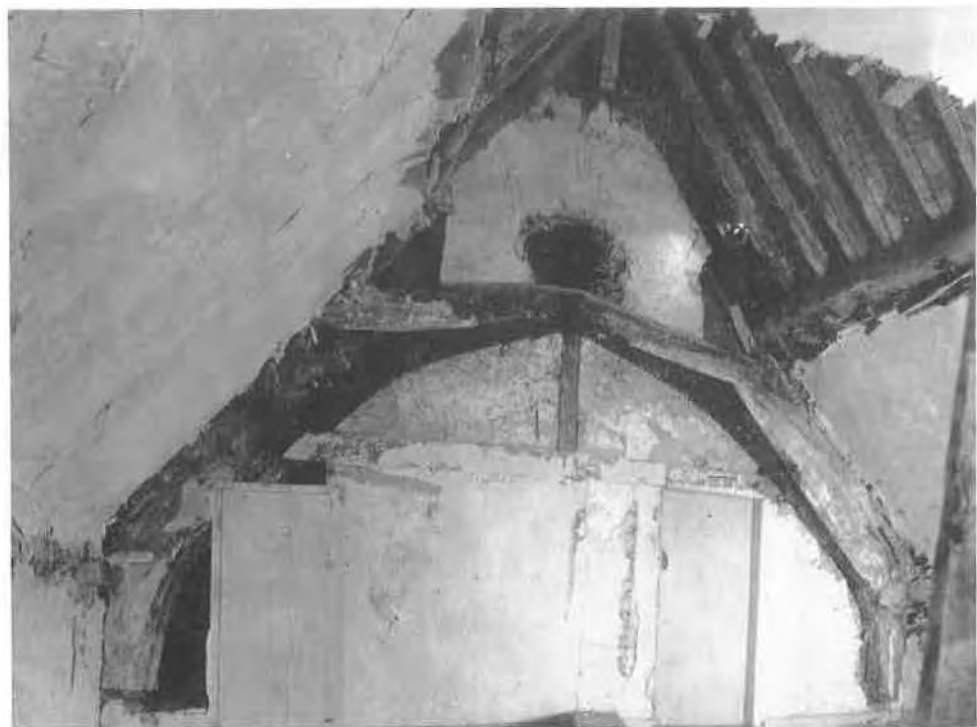
PLATE III (a). Cruck.

The carpenters dispensed with a tie-beam and fitted instead an arch-braced collar.⁷ The timbers had been carefully dressed and chamfered (Plate IIIa and Fig. 6). The few examples of these collars which have been recorded are usually found in single-storey halls of somewhat superior construction.⁸

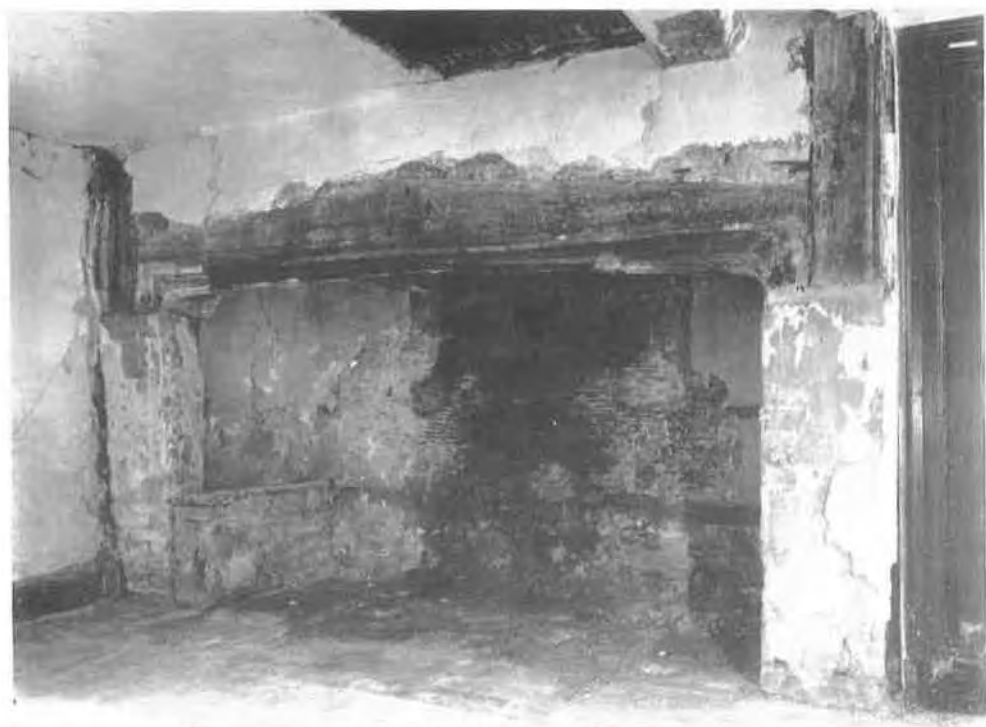
PLATE III (b). Hall fire place.

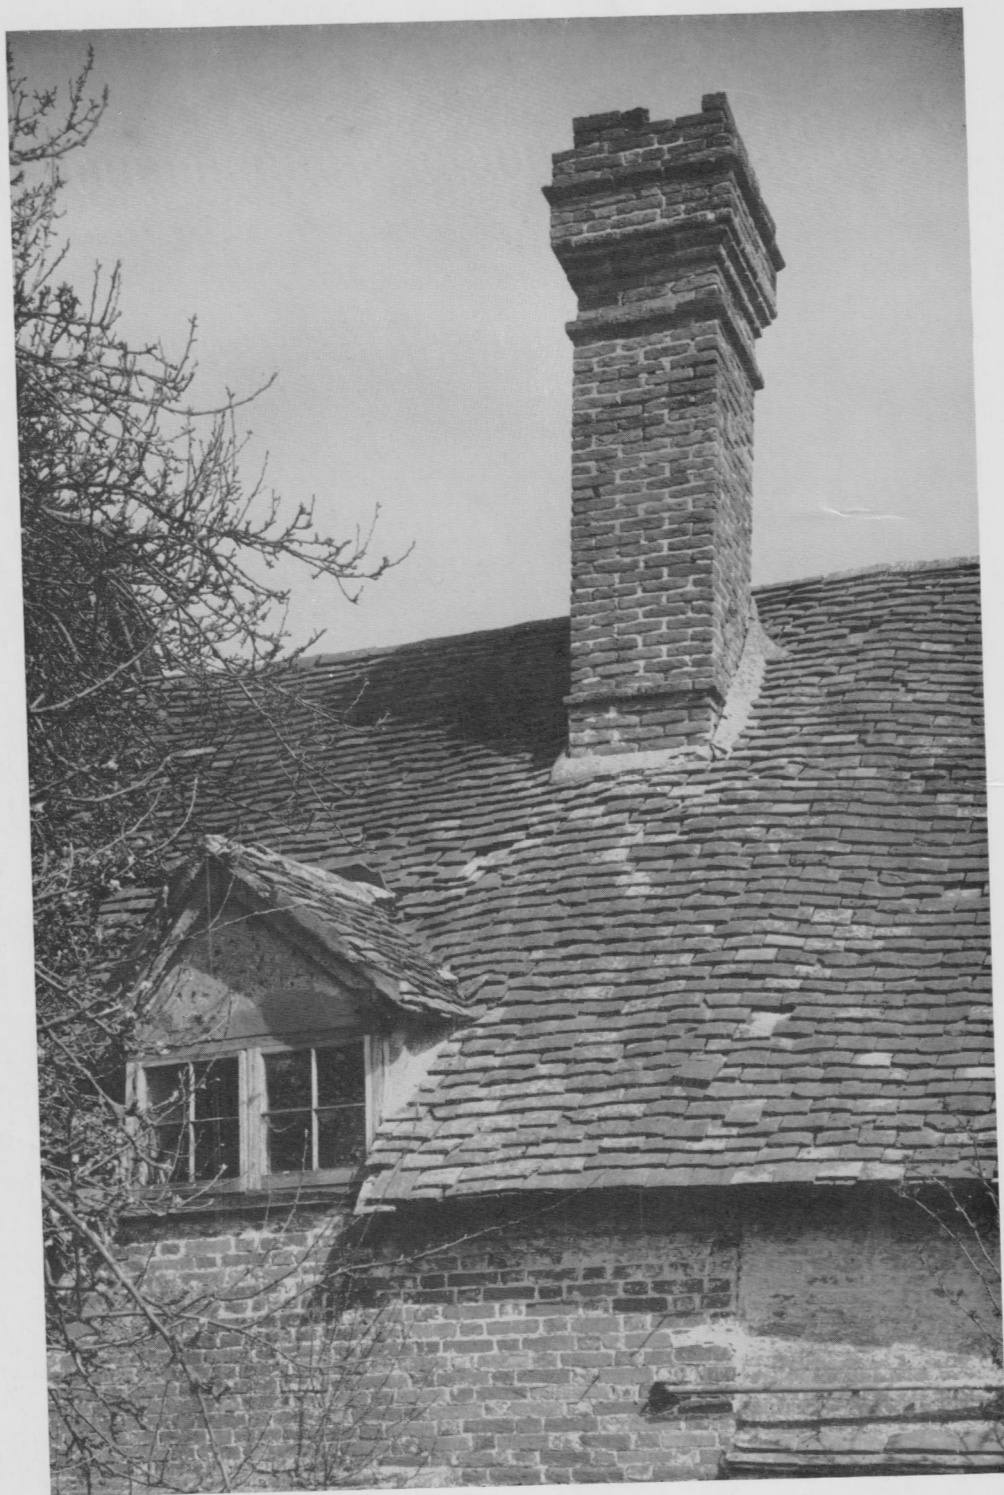
PLATE IV. 16th century chimney.
