AN ACCOUNT OF THE CHURCH OF ST. MARY  
AT TURVILLE, BUCKS, AND OF ITS RECENT  
RESTORATION AND ENLARGEMENT.

# CHURCH OF ST. MARY TURVILLE, BUCKS. AS RESTORED IN 1900

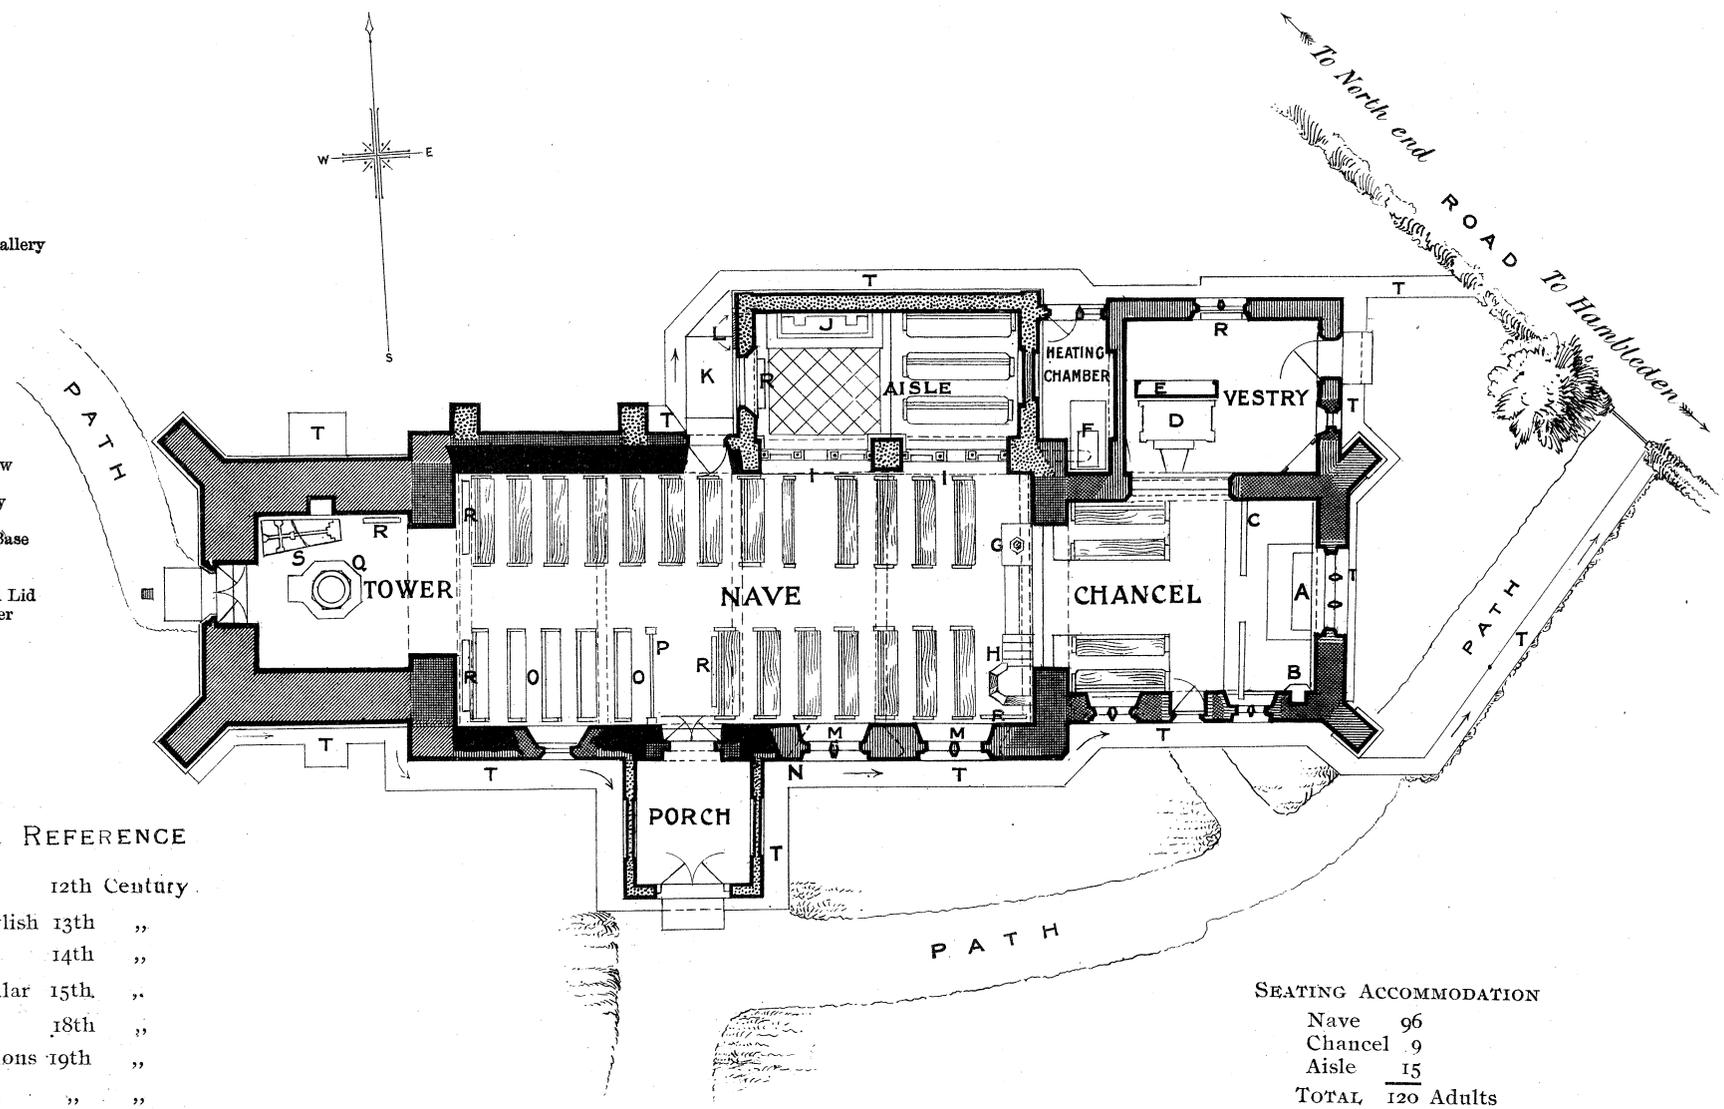
Nave	96
Chancel	9
Aisle	15
<b>TOTAL</b>	<b>120 Adults</b>

W. A. FORSYTH, A.R.I.B.A.,  
 HUGH P. G. MAULE,  
 Architects,  
 16, Great Marlborough St.,  
 London, W.

The Church, dedicated to St. Mary, is a very interesting specimen of a small country Church, broad and simple in character, and of good proportions. It now consists of a Nave with a small north aisle, Chancel, Tower, Vestry, Heating Chamber, and south Porch: the internal dimensions of the various parts are as follows:—

Length.	Width.	Height.
Nave —	43ft. 0in. by	18ft. 9 in.	26ft. 6in. to apex of roof.
Aisle —	19ft. 9in. by	9ft. 9in.	12ft. 6in. to ceiling.
Chancel—	18ft. 10in. by	14ft. 5in.	16ft. 6in. to ceiling.
Tower —	12ft. 0in. by	11ft. 7in.	17ft. 0in. first floor.
Vestry —	14ft. 6in. by	11ft. 0in.	13ft. 6in.
Heating Chamber } —	11ft. 0in. by	6ft. 0in.	
Porch —	9ft. 6in. by	8ft. 10in.

Seating accommodation is provided for 120 adults, the distribution being 96 in the nave, 9 in the chancel, and 15 in the aisle.
