PLACE HOUSE, HORTON, (FORMERLY BUCKINGHAMSHIRE); THE HOUSE AND GARDEN AND ITS SUCCESSOR.

MICHAEL FARLEY

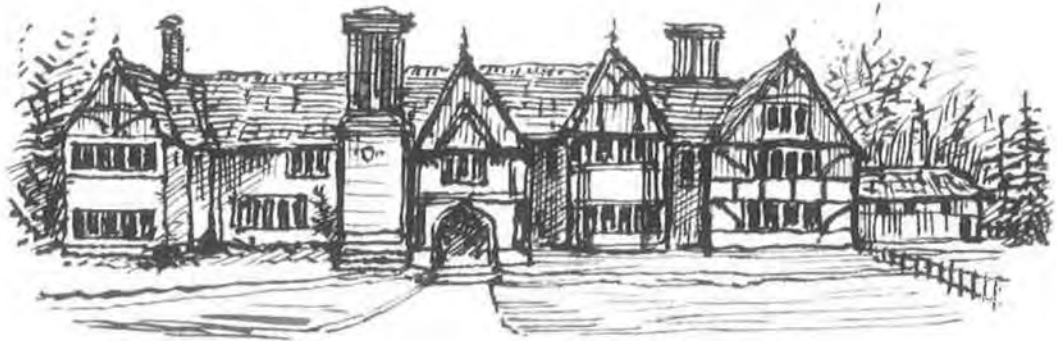
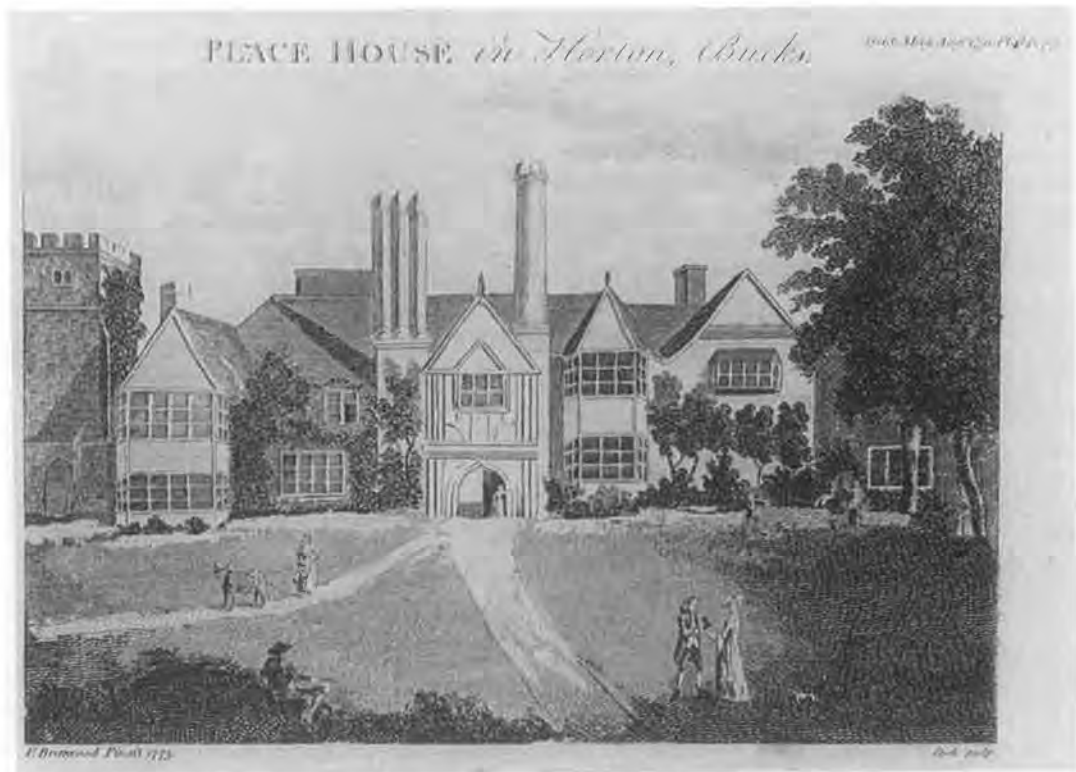
FIGURE 1

*Place House, Horton Bucks. From an old pen & ink
Drawing, circa 1705.*

Upper: Place House, Horton circa 1705. Reproduced courtesy the Bodleian Library (Ms. Top. Bucks, c.1. f 54 facing.)

Lower: Place House, Horton in 1773. Print in BAS collections (BAS 4/56)

Plate III [here Fig 1, lower] presents a West view of Place House, in Horton, near Colnbrook, Bucks. The manor of Horton did belong to the Scawens, who sold it some time ago. Sir Thomas Scawen knt. Alderman of London, appears to be the last owner of it in the family. It is now in a widow lady of the name of Hickford ... [who is said] ... to have purchased the manor of a Mr Cook of Beaconsfield. This mansion was occupied by Thomas Brerewood the elder, the beginning of this century; it appears to have been built about the early part of Elizabeth's reign, and was

The print published in the *Gentleman's Magazine* (Fig 1, lower) shows, it is stated, a 'west view' of the house immediately adjacent to the tower of the parish church of St Michael. Lipscomb (1847, IV, 510), presumably also working from the print, describes the house as being 'adjacent to the south side of the tower of the Church'

There are some significant differences between the '1705' drawing and the later Brerewood image of 1773. For example, the later drawing has a massive chimney on the right hand side of the porch not present on the earlier one and some detail shown in the earlier drawing is on the later one obscured by vegetation. It seems likely, therefore, that although Lee may have done some tidying up, the image he copied was not the *Gentleman's Magazine* image but, as he indicated, an earlier drawing.

The 1773 drawing, as previously noted, shows the main building apparently aligned N-S, judging from its relationship to the church tower, which unfortunately the earlier drawing does not show. The earlier drawing is, however, on the whole more informative and is used for the description below. The terms north and south relate to the presumed alignment of the structure.

Two principal ridge levels are apparent in the 1705 drawing and the roofs appear to be tiled. The main block, which can be presumed to be the original structure, has a two-storey porch about two-thirds along its length which from many examples known elsewhere, would give access to a cross-passage at the lower end of the hall. The porch has a pointed arch with rectangular fenestration above. Both the earlier and later drawings show diagonal timbers in the gable end. The later drawing apparently shows lateral pilasters at ground and first floor level, but as on the upper floor there are diagonal braces all of these features are likely to be of timber. To the left of the porch is a substantial multiple chimney, rising from ground level. Left of this are two levels of windows, presumably illuminating an open hall, or a hall into which an upper floor

has been inserted. Next is a projecting northern wing with an irregularity at the junction between the main building and wing perhaps related to the single chimney arising above. The wing has upper and lower full-width windows, above which there is evidence of timber-framing in the gable end including diagonal braces. The later drawing seems to indicate that the bay may be canted.

To the right of the porch is a second projecting bay, with upper and lower windows apparently canted. Between porch and bay are one, or possibly two, windows in the main wall. A second ridge level, shorter and slightly lower, continues the alignment of the main building to the south. Projecting from it is a third broad bay with diagonal braces at ground and first floor level. There are windows at all three levels. In the later drawing only the upper window is visible; here it appears to be an oriel window. One upper floor single-light window is just visible in the wall between the two wings. Clustered chimneys are apparent at the roof ridge. To the right of the whole is a small single-storey extension with chimney and small openings or windows. Although largely concealed by a tree in the later drawing a larger window is indicated, suggesting that the structure may have been modified subsequent to the 1705 drawing. The most significant structural difference between earlier and later drawings are the arrival of a massive chimney stack to the right of the porch by 1773, and of another chimney block or possibly an additional roof ridge behind the northern end of the principal block.

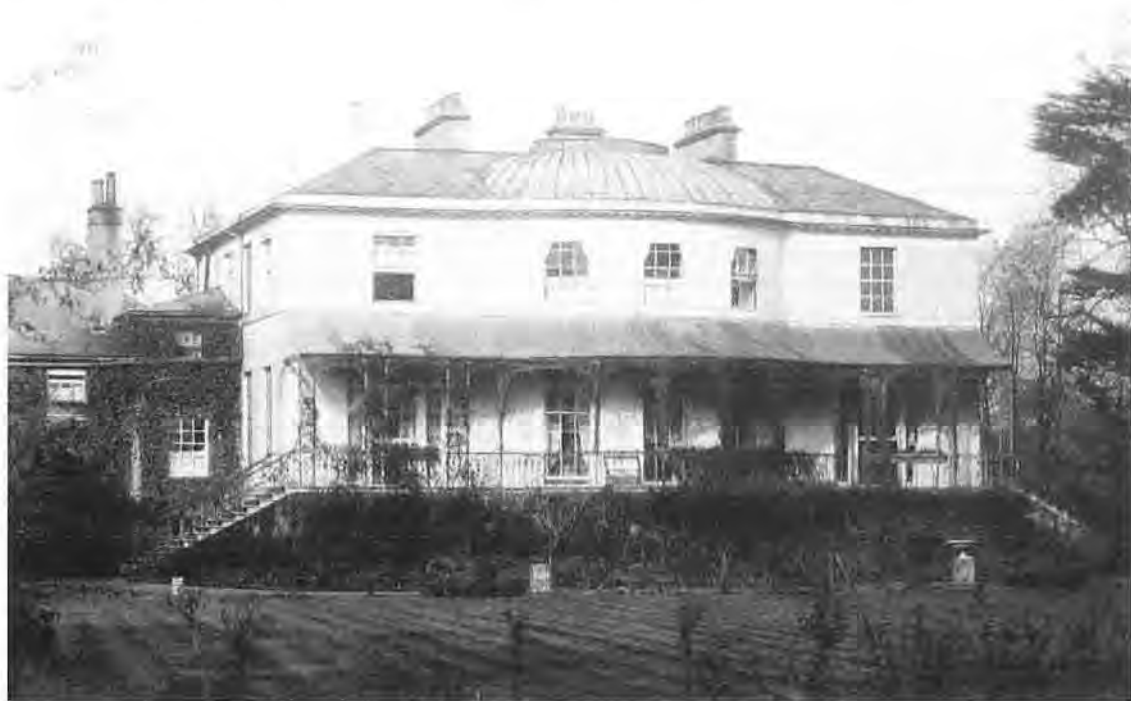
FIGURE 4 Horton Manor, successor to Place House, from a sale catalogue of 1905, kindly loaned by Mr and Mrs Marlow.

Following the death of General Owen Williams, the estate went on sale on June 6th 1905. A sale catalogue is in the possession of Mr and Mrs Marlow of Horton who kindly showed the writer. A photograph from the catalogue is included here (Fig 4) and a few details:

Freehold Residential and Agricultural Properties embracing an Area of 1,215 acres, and known as the Horton and Wraysbury Estates in the Counties of Bucks and Middlesex.... Comprising the well-known mansion, situated in the midst of a beautifully timbered Park, and known as "Horton Manor". [the mansion] substantially erected in brick with pleasing elevation in slate weathering, is slated except the dome-shaped portion which is covered with copper. It is entered with a flight of 12 stone steps through a handsome porch, which is supported on four stone columns ...

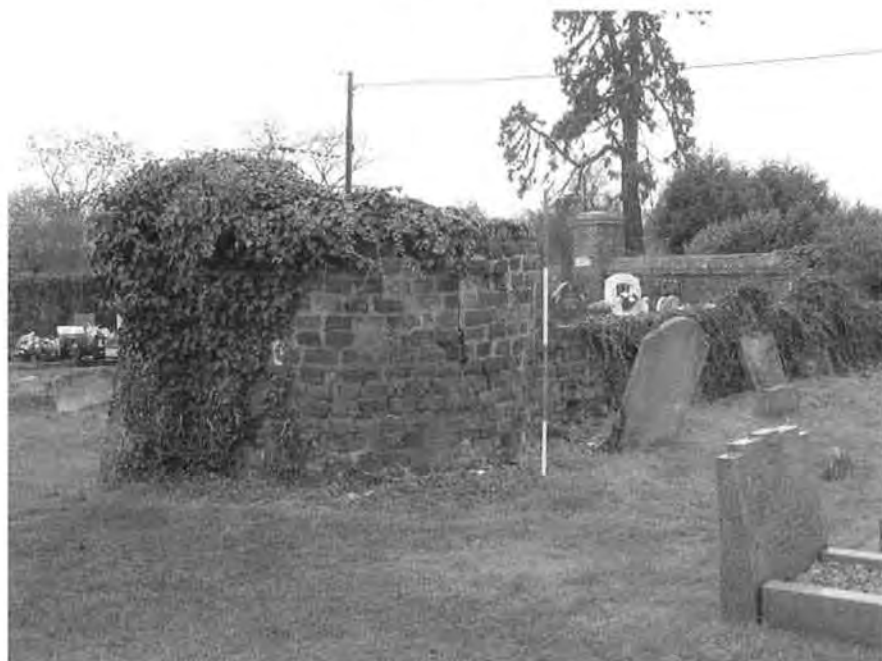
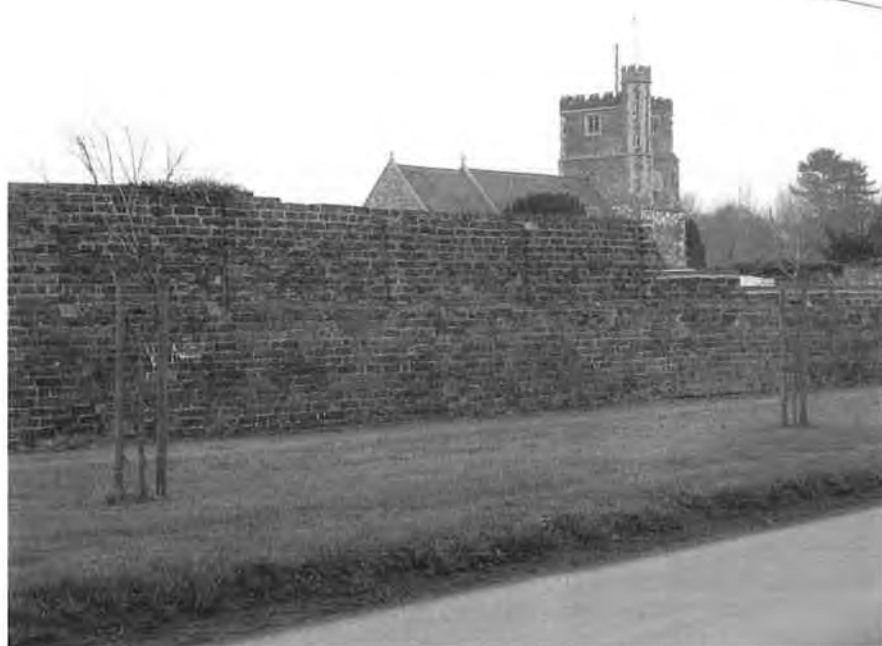
FIGURE 6

Upper: North 'bastion' of Wall 2, looking towards Stanwell Road with gateway in Wall 7 visible behind.
Lower: Wall 4 fronting Stanwell Road with both base and pilaster features built of large bricks.

4. As noted above this wall, which is made mostly of large brick with some original pilaster and recess features at its east end (Fig 6, lower), extends about 56m along the road. It terminates at a field entrance at the site of a former building (g) built against its southern face. This structure was occupied within living memory. The wall end, apparently finished, was close to the terminal of the N-S canal previously noted. Together with the churchyard wall and the canal, it would have formed a three-sided rectangular enclosure.

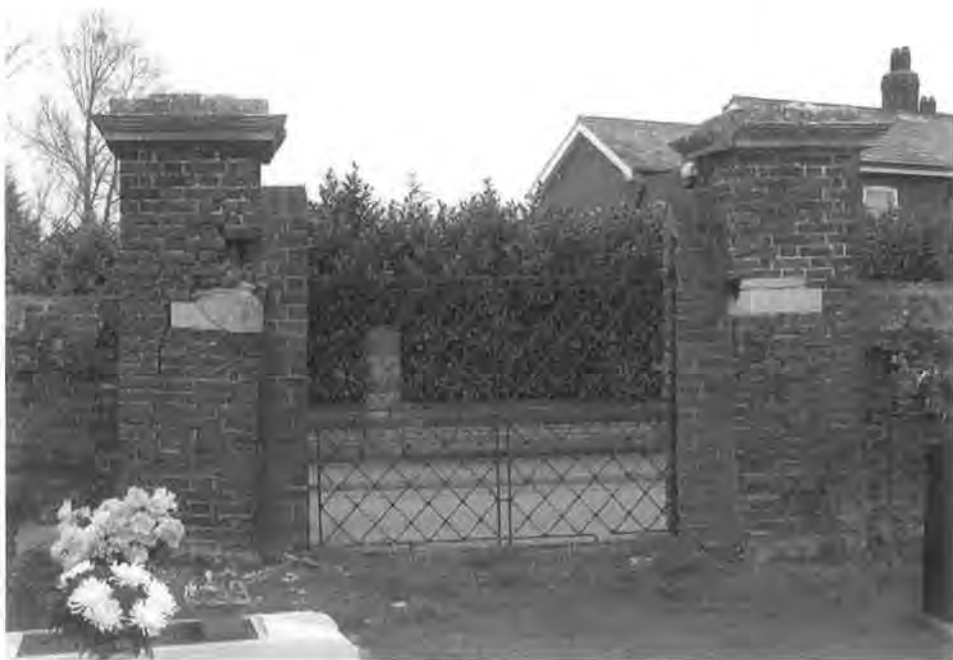
FIGURE 7 Gateposts in Wall 7 fronting Stanwell Road, at presumed north end of the driveway to Place House.

7. This wall is also built in narrow bricks. It has a central entrance with two brick pillars either side with stone capitals (Fig 7). Two stone blocks, whose function is uncertain but may have supported gate hinges are set in the upper part of the inner face. If the interpretation that the land behind once formed a driveway to Place House is correct, then this gateway is quite narrow for such an entrance, but it is difficult to see a reason for it being constructed later. It clearly pre-dates the cemetery extension.
